HONEYCOMB

HOUSE INSPECTION REPORT

Inspection Report

INS00012

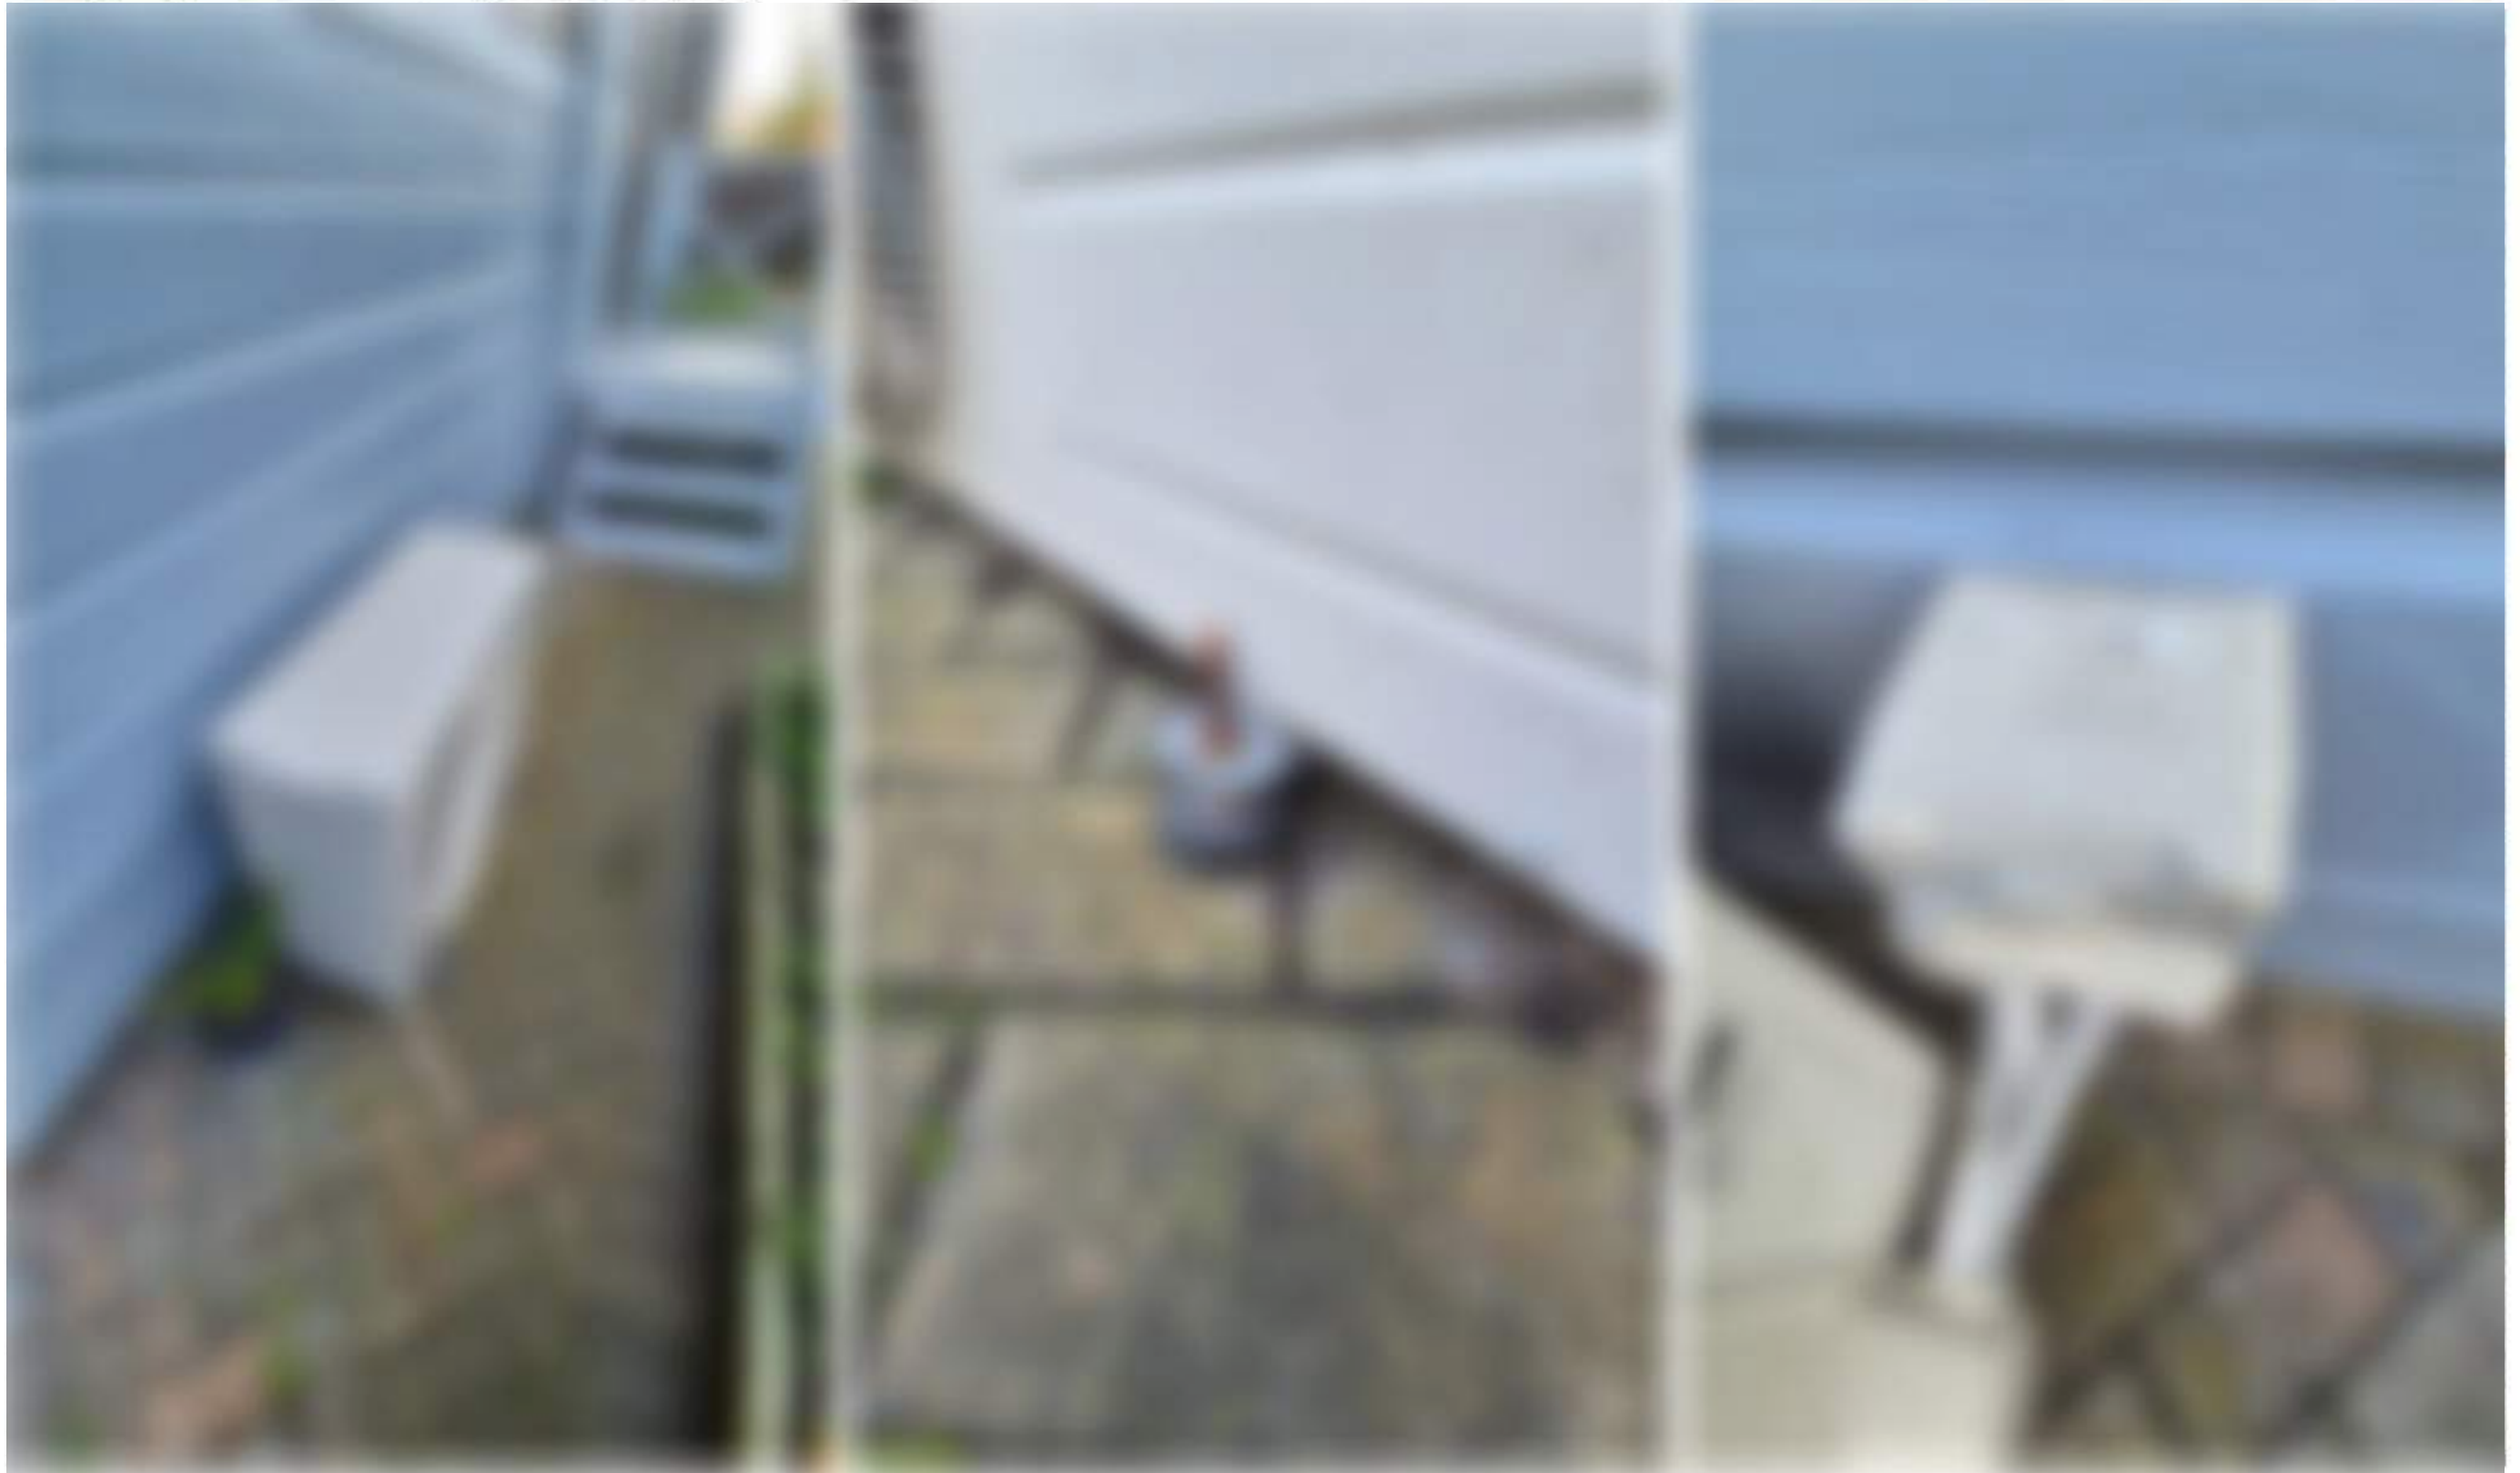
4.2 Heat Pumps

Not tested, advised to test at settlement inspection.

Fixings appears to be rusting, advised to replace.

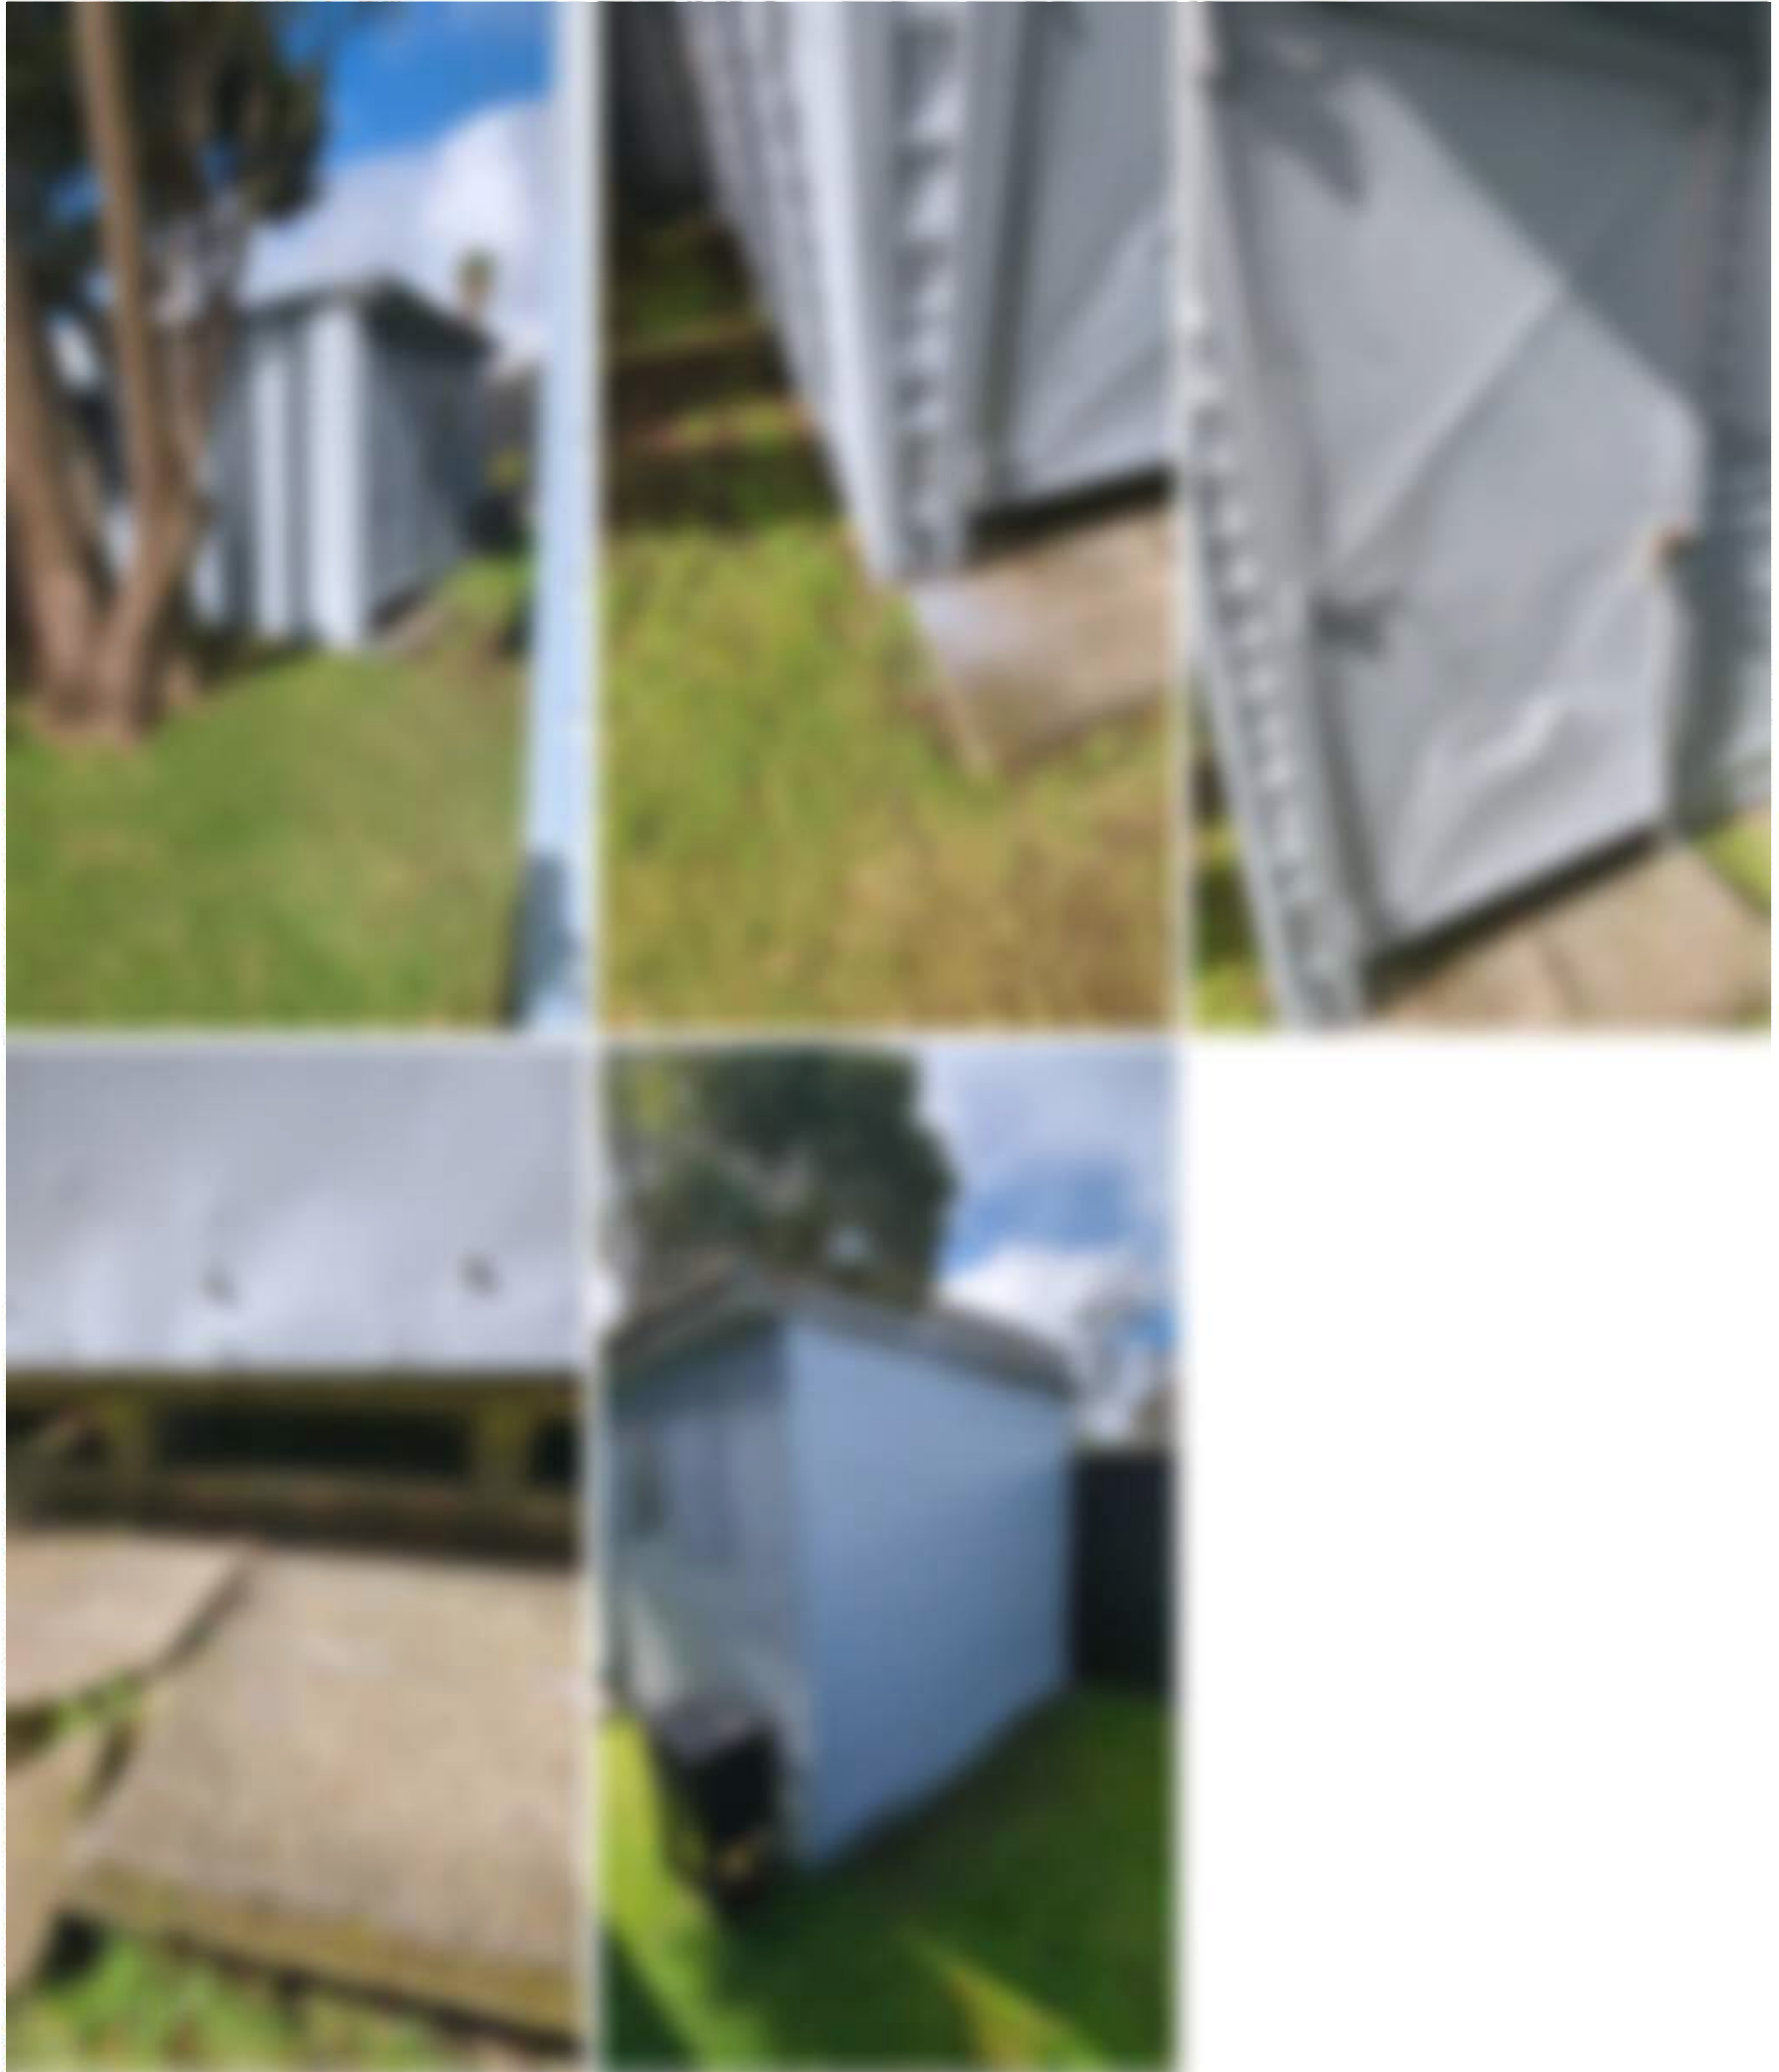
Garden shed appears to be rusting/damaged, advised to replace.

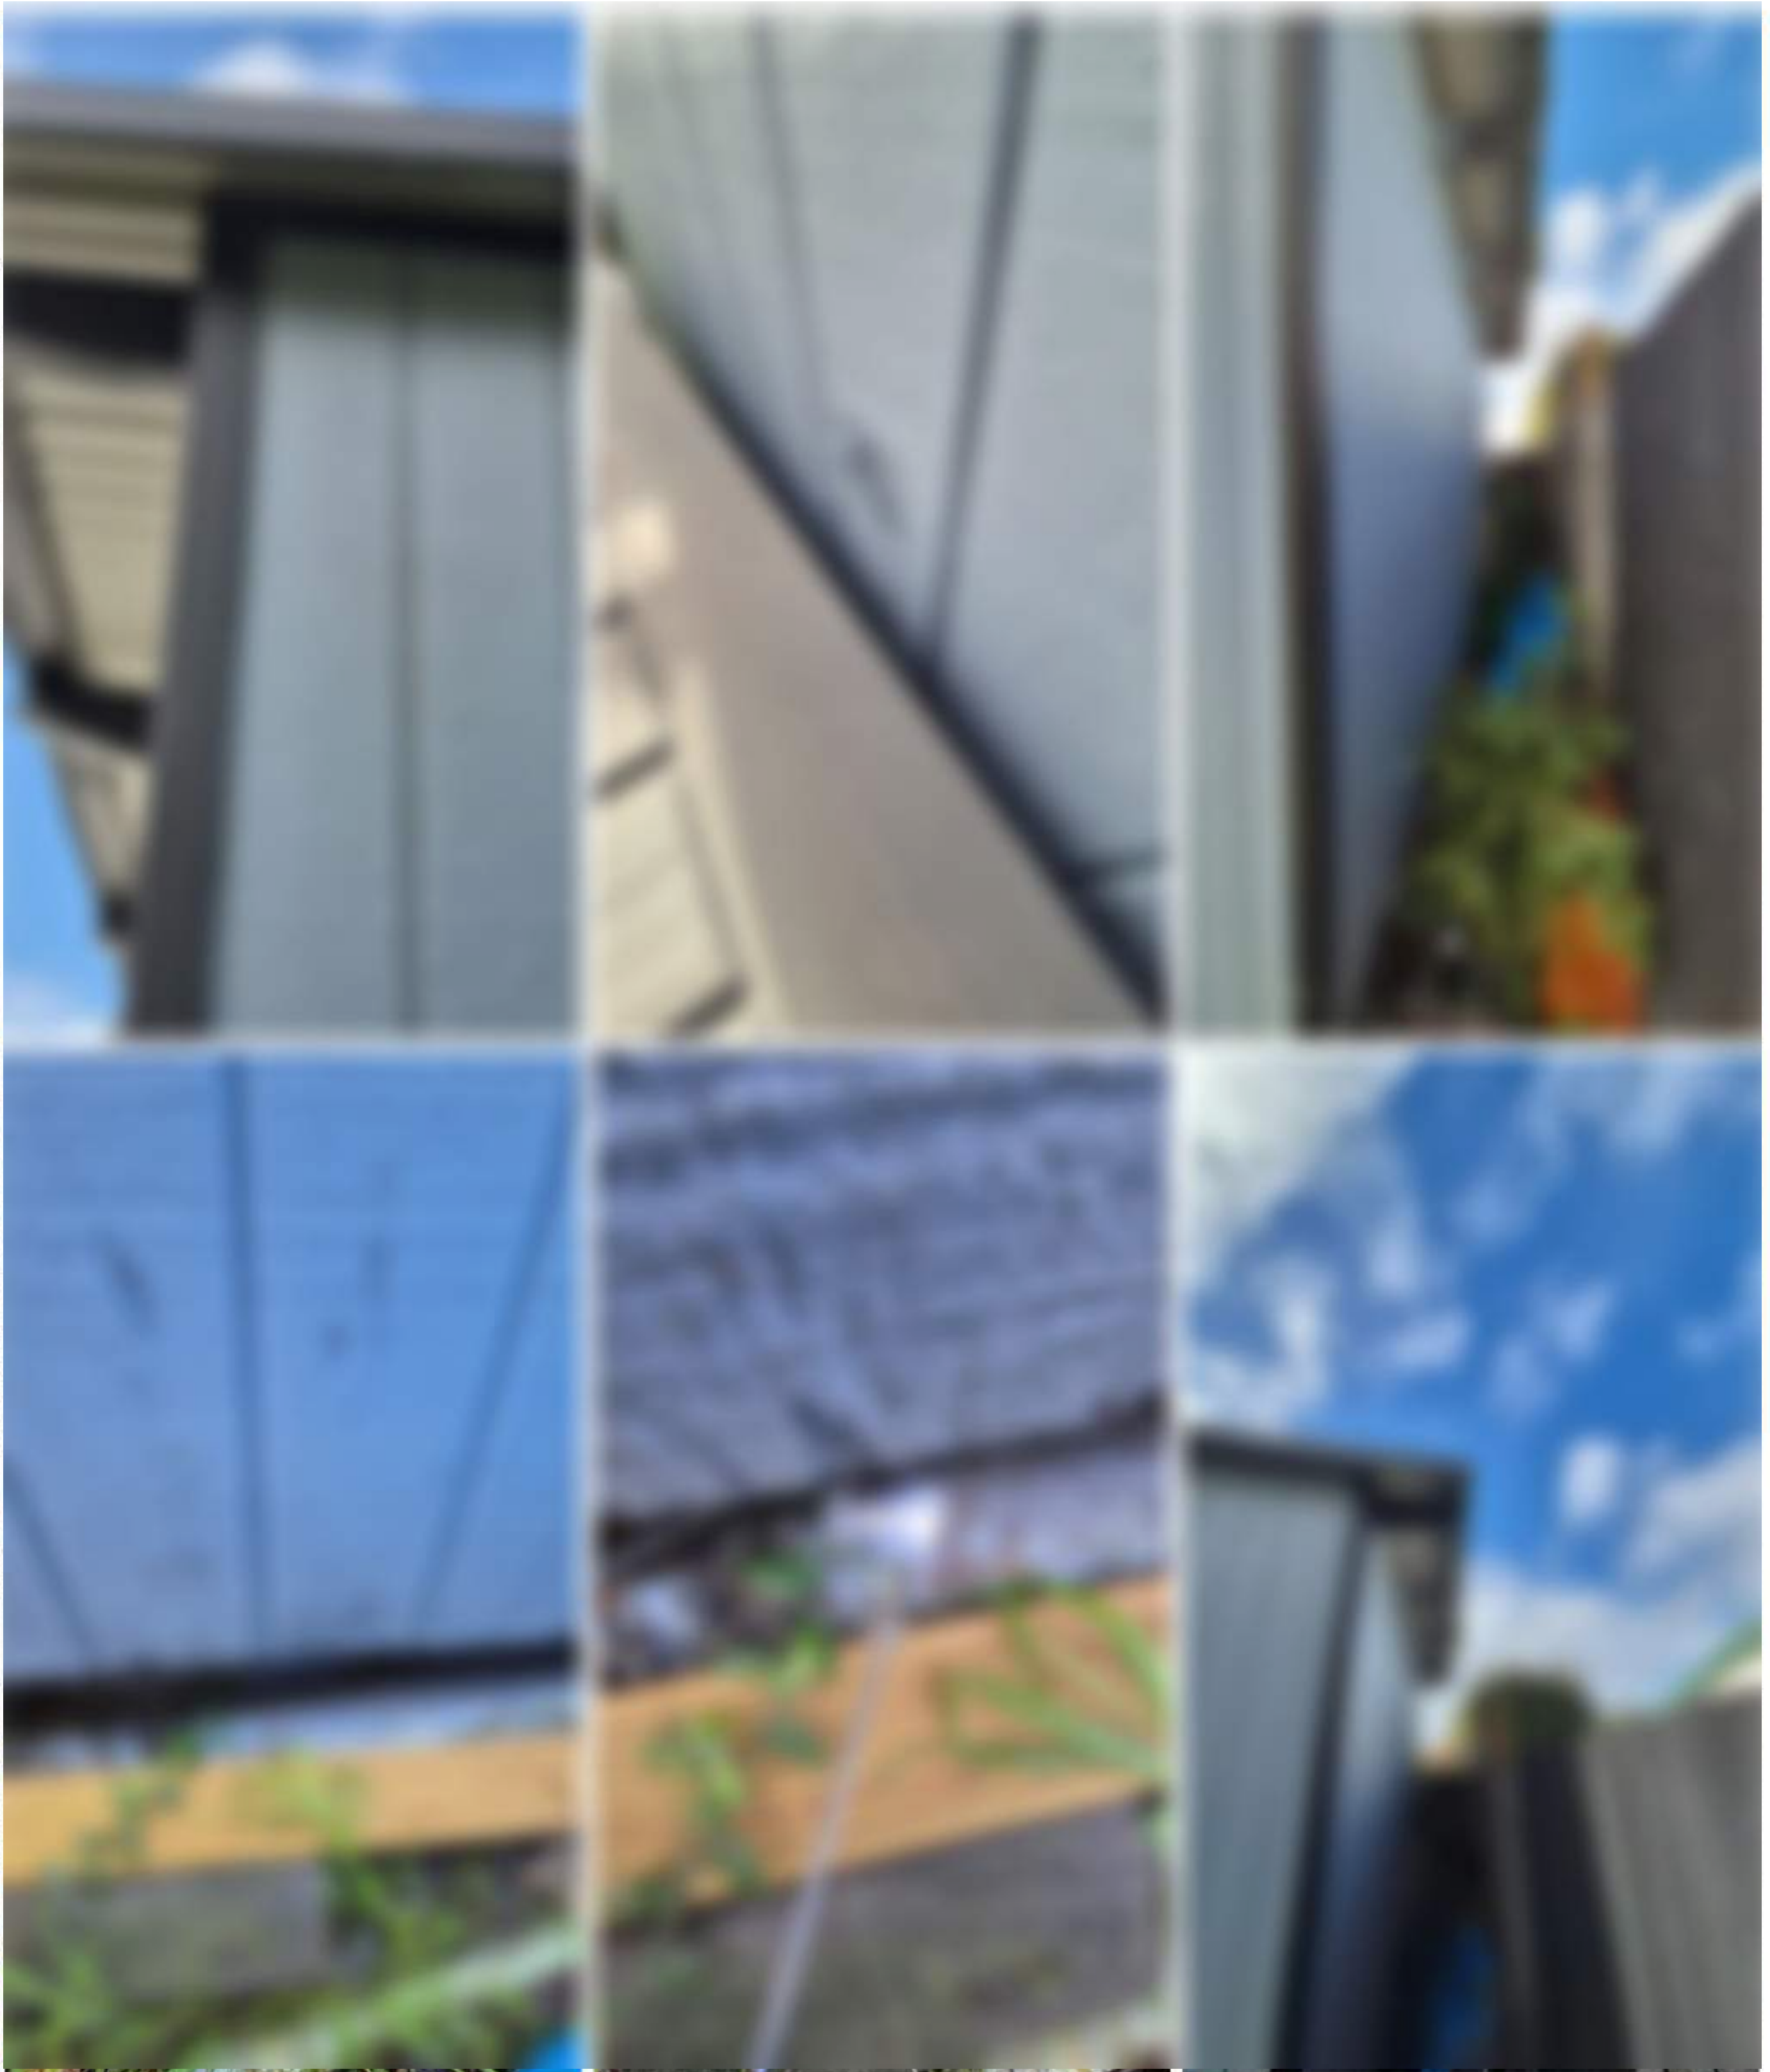
4.7 Sleep out/Office

The cladding to head flashing clearance appears to be insufficient, typically 5mm min. The head flashing are joined or short, or there is no head flashing installed. The issue that can arise is water ingress leading to structural rot and damage to the property. Where the clearance is insufficient the water may pond between the cladding and head flashing by capillary action. Deteriorating each material till water ingress occurs. Costs may be significant to rectify the issues.

There appears to be damage to the cladding in certain areas. This could lead to water ingress, potentially causing structural damage. The back of the sheet/cut edges does not appear painted and appears black/mouldy, this may void the warranty. Check if the consented plans if the cladding is shadowclad.

Further investigation required.

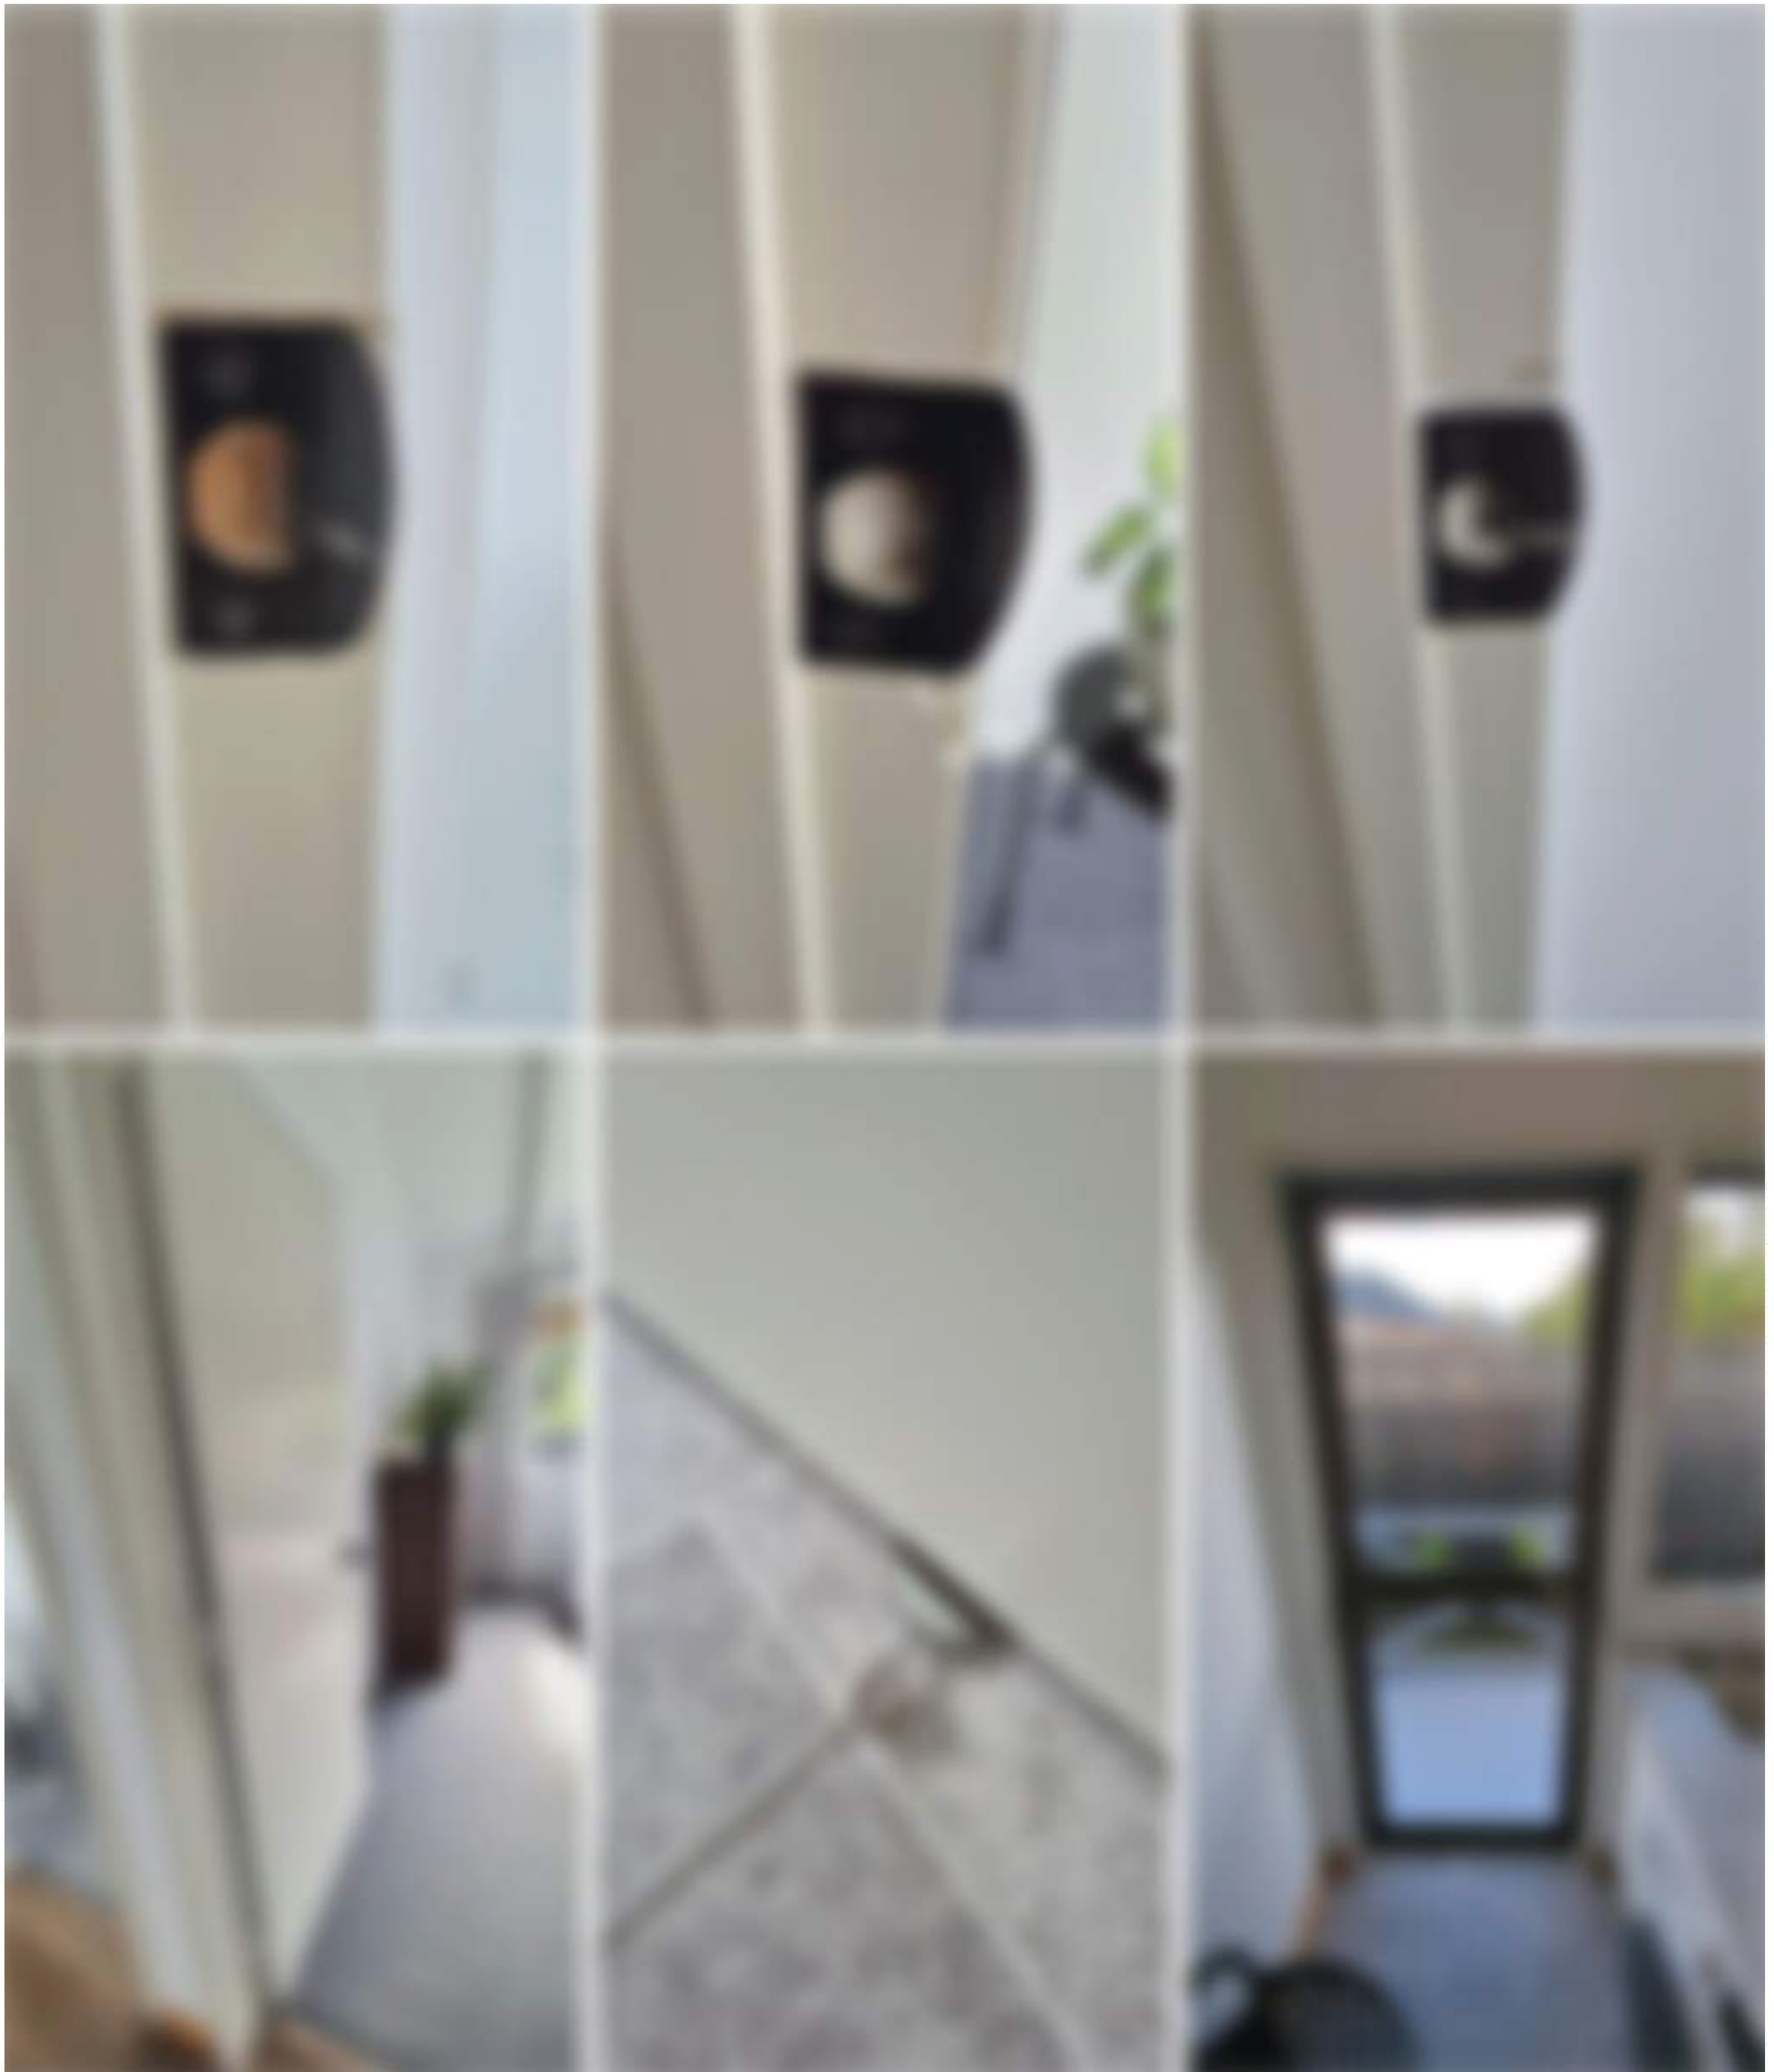
6.3 Doors and Hardware

The doors need adjustments/replacement to the seals, locks or trimmed down etc.

- Door tops/bottoms unpainted
- Damaged doors, frames and finishings
- Age related wear noted to hardware
- Defective door hardware

Advised to replace joinery to double glazed units.

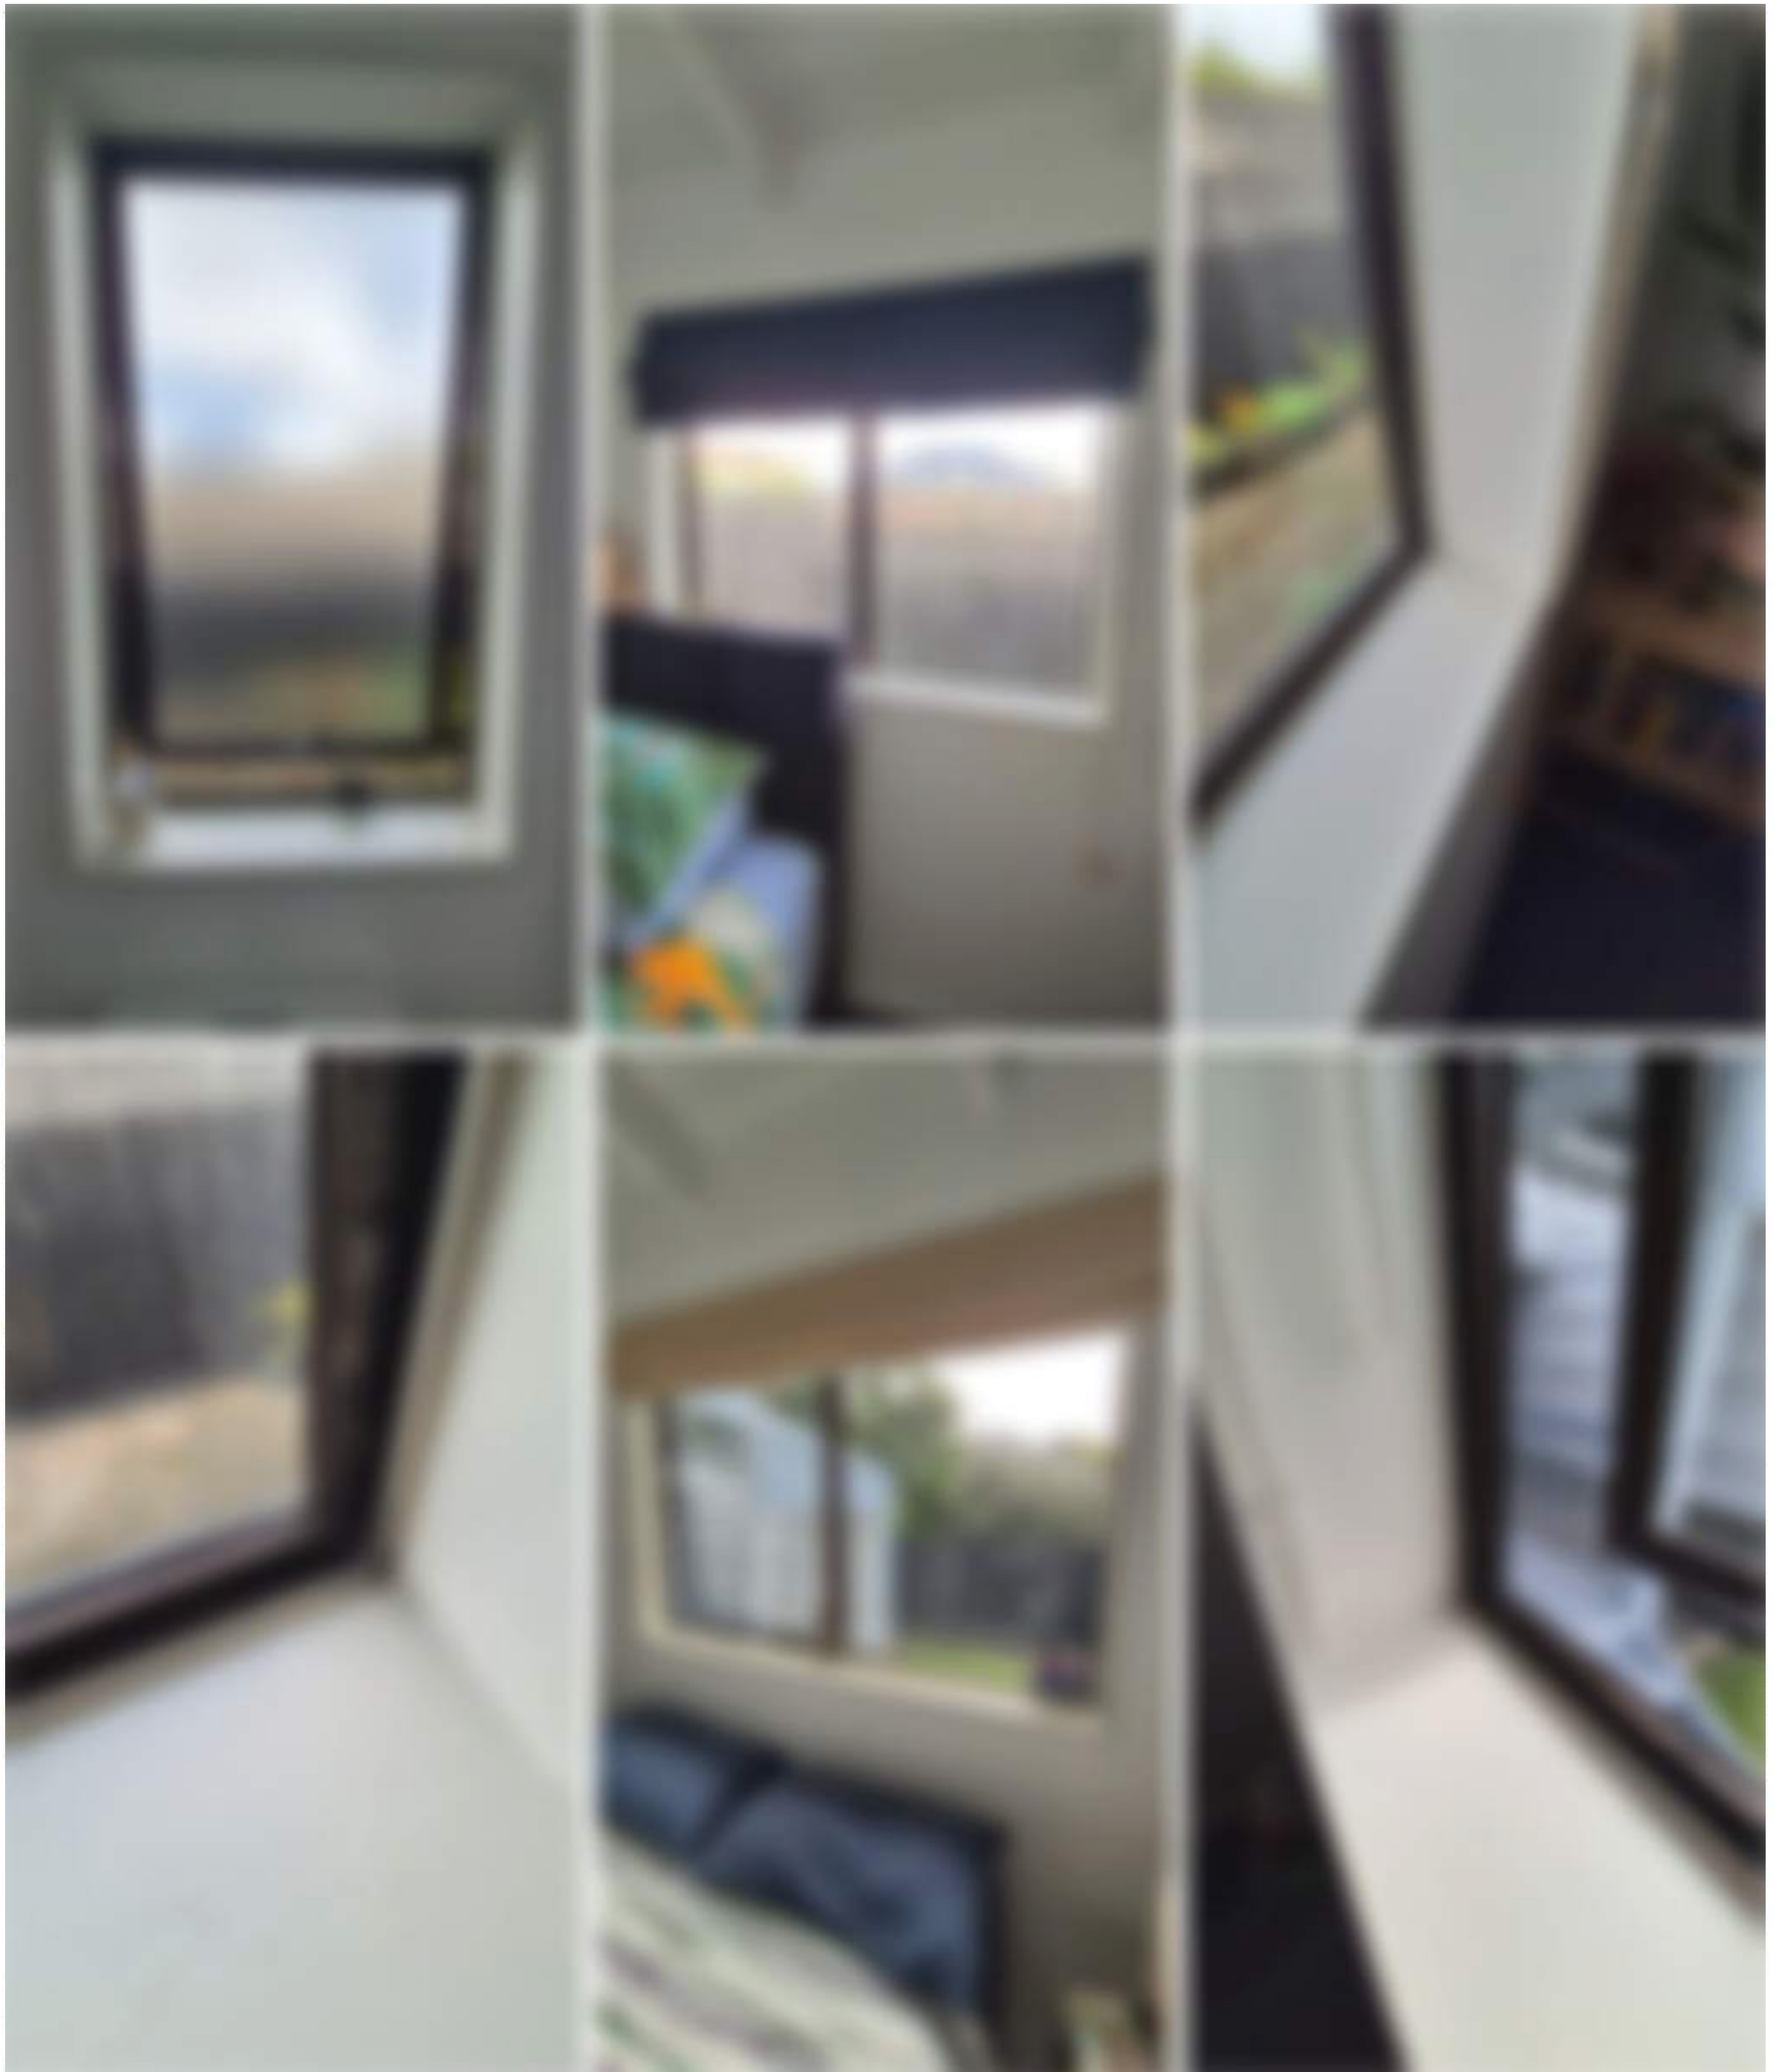
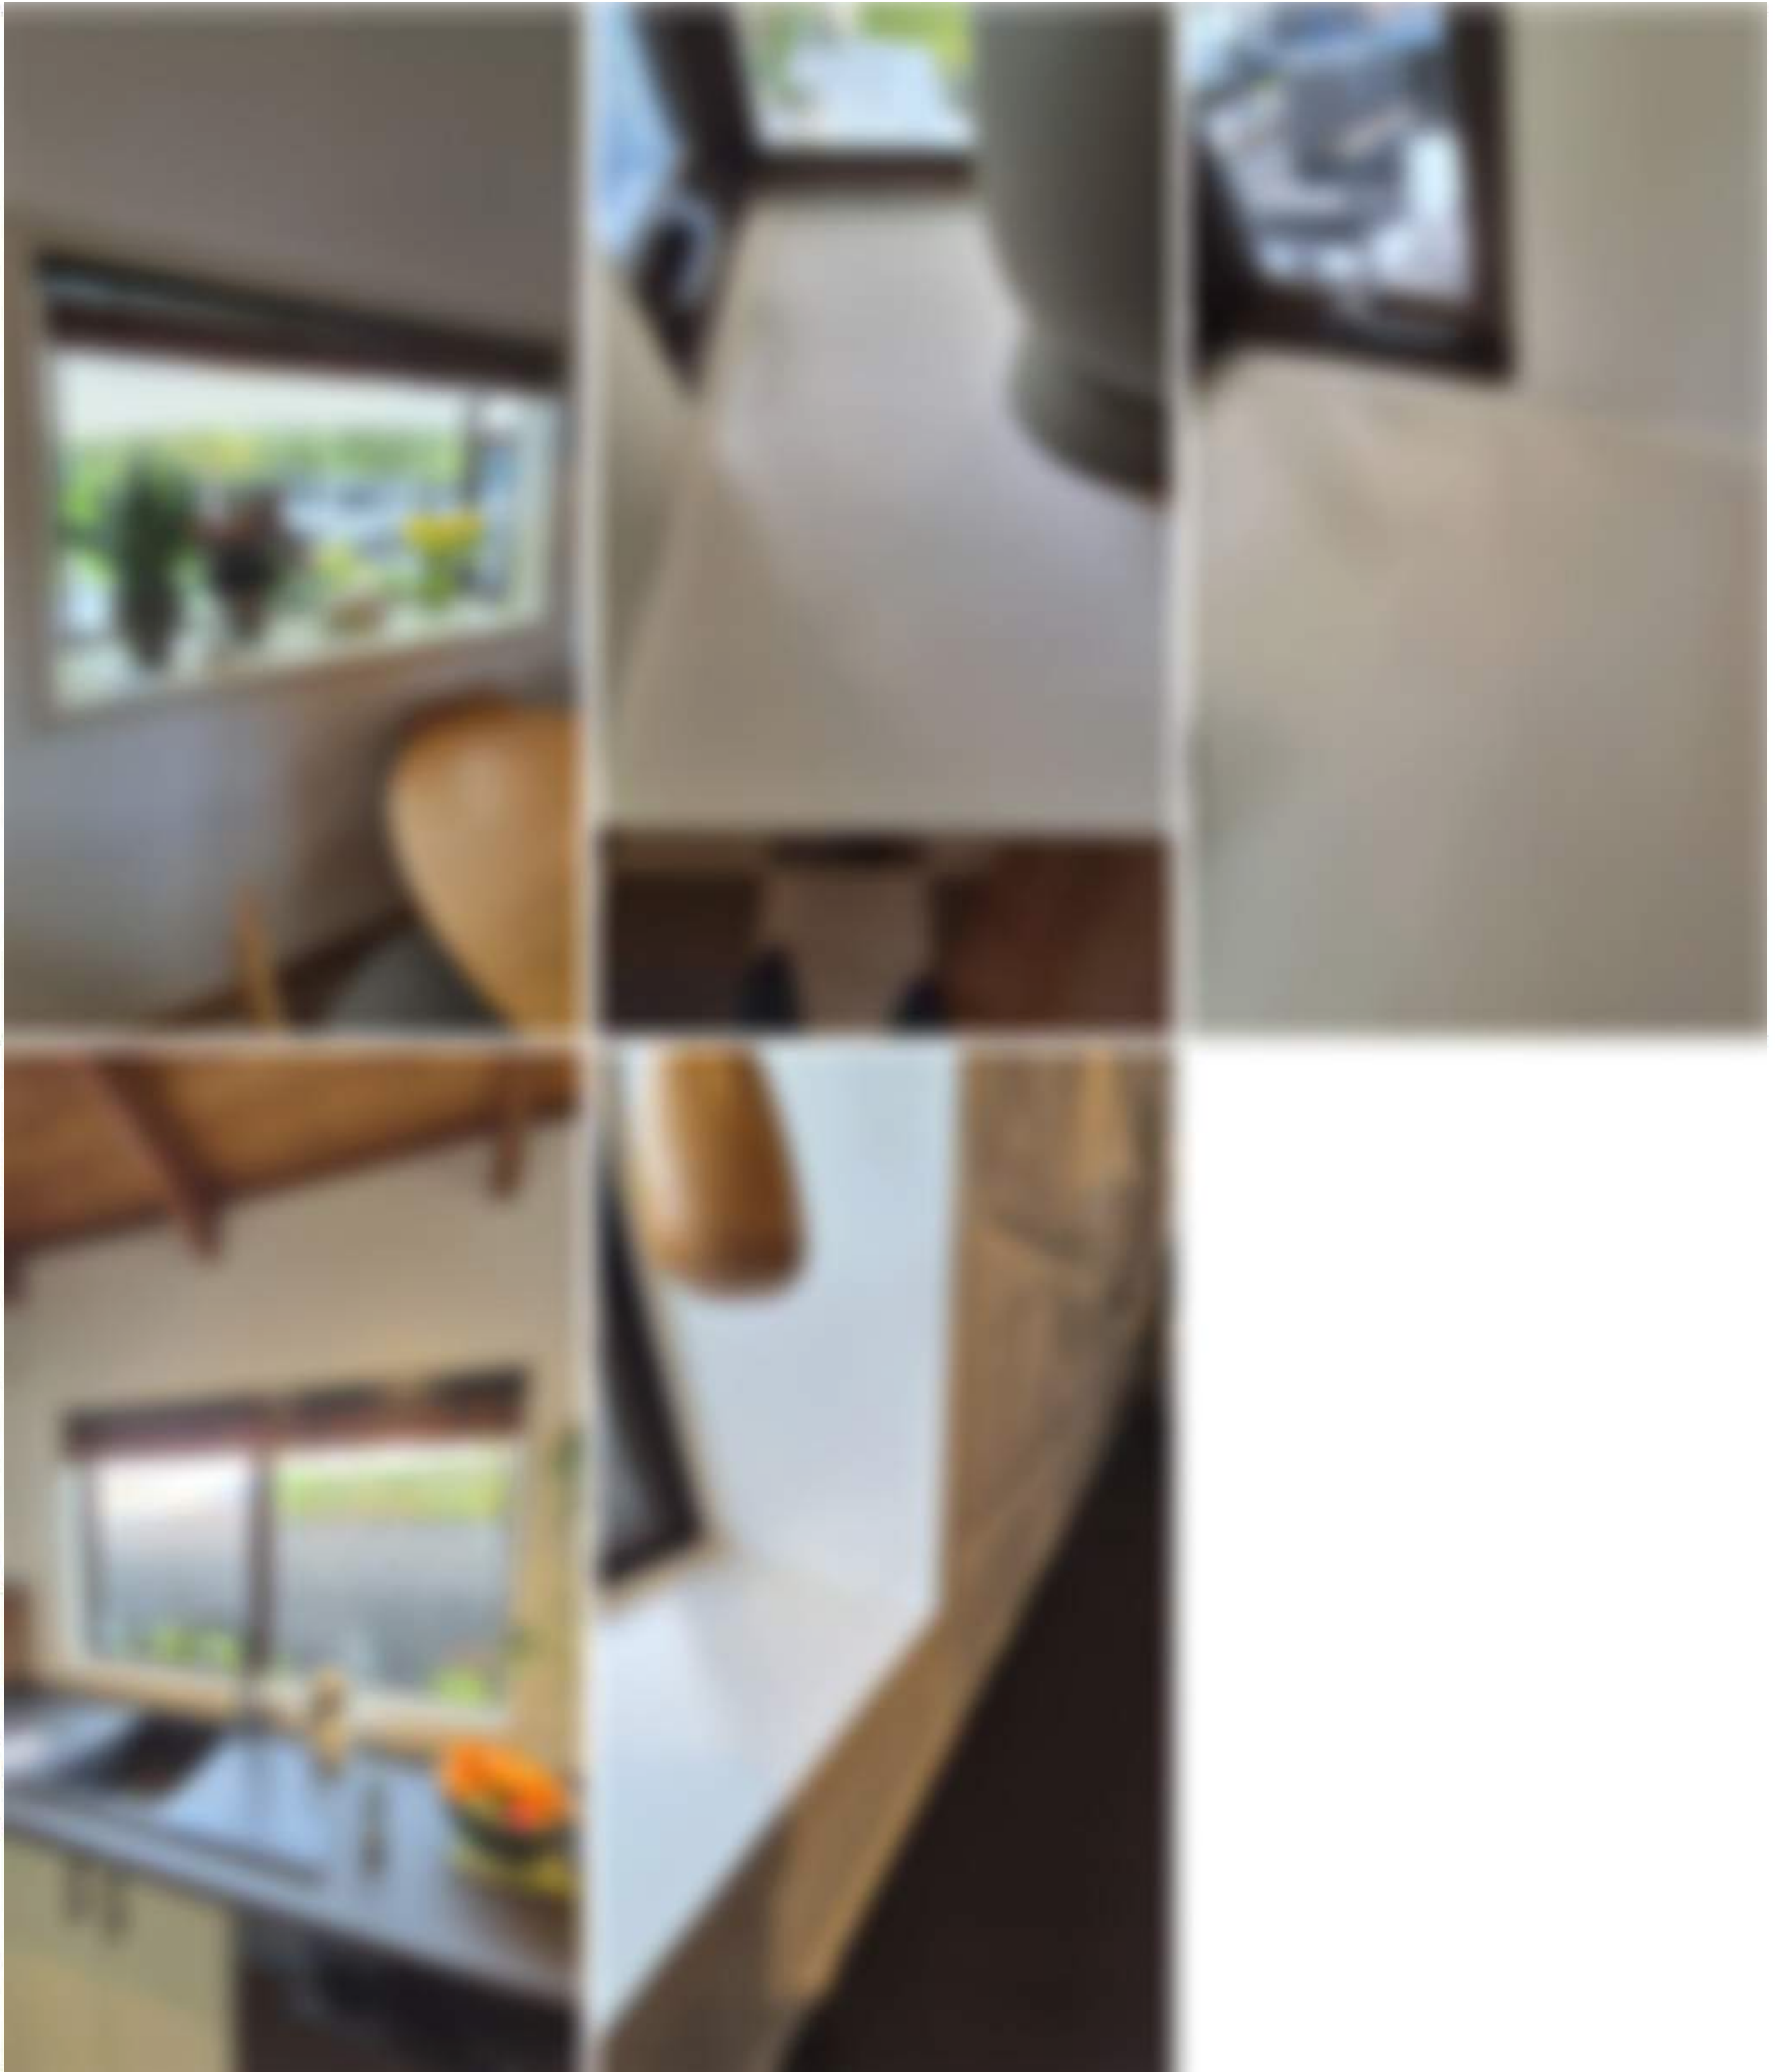
6.4 Window/Window Hardware

There appears to be missing screw on the catch.

- The use of non safety glass to low windows may have been acceptable at the time of construction
- Age related wear noted to hardware
- The current building code would require safety glass to be fitted

Advised to replace joinery to double glazed units.
