HONEYCOMB

HOUSE INSPECTION REPORT

Inspection Report

INS00012

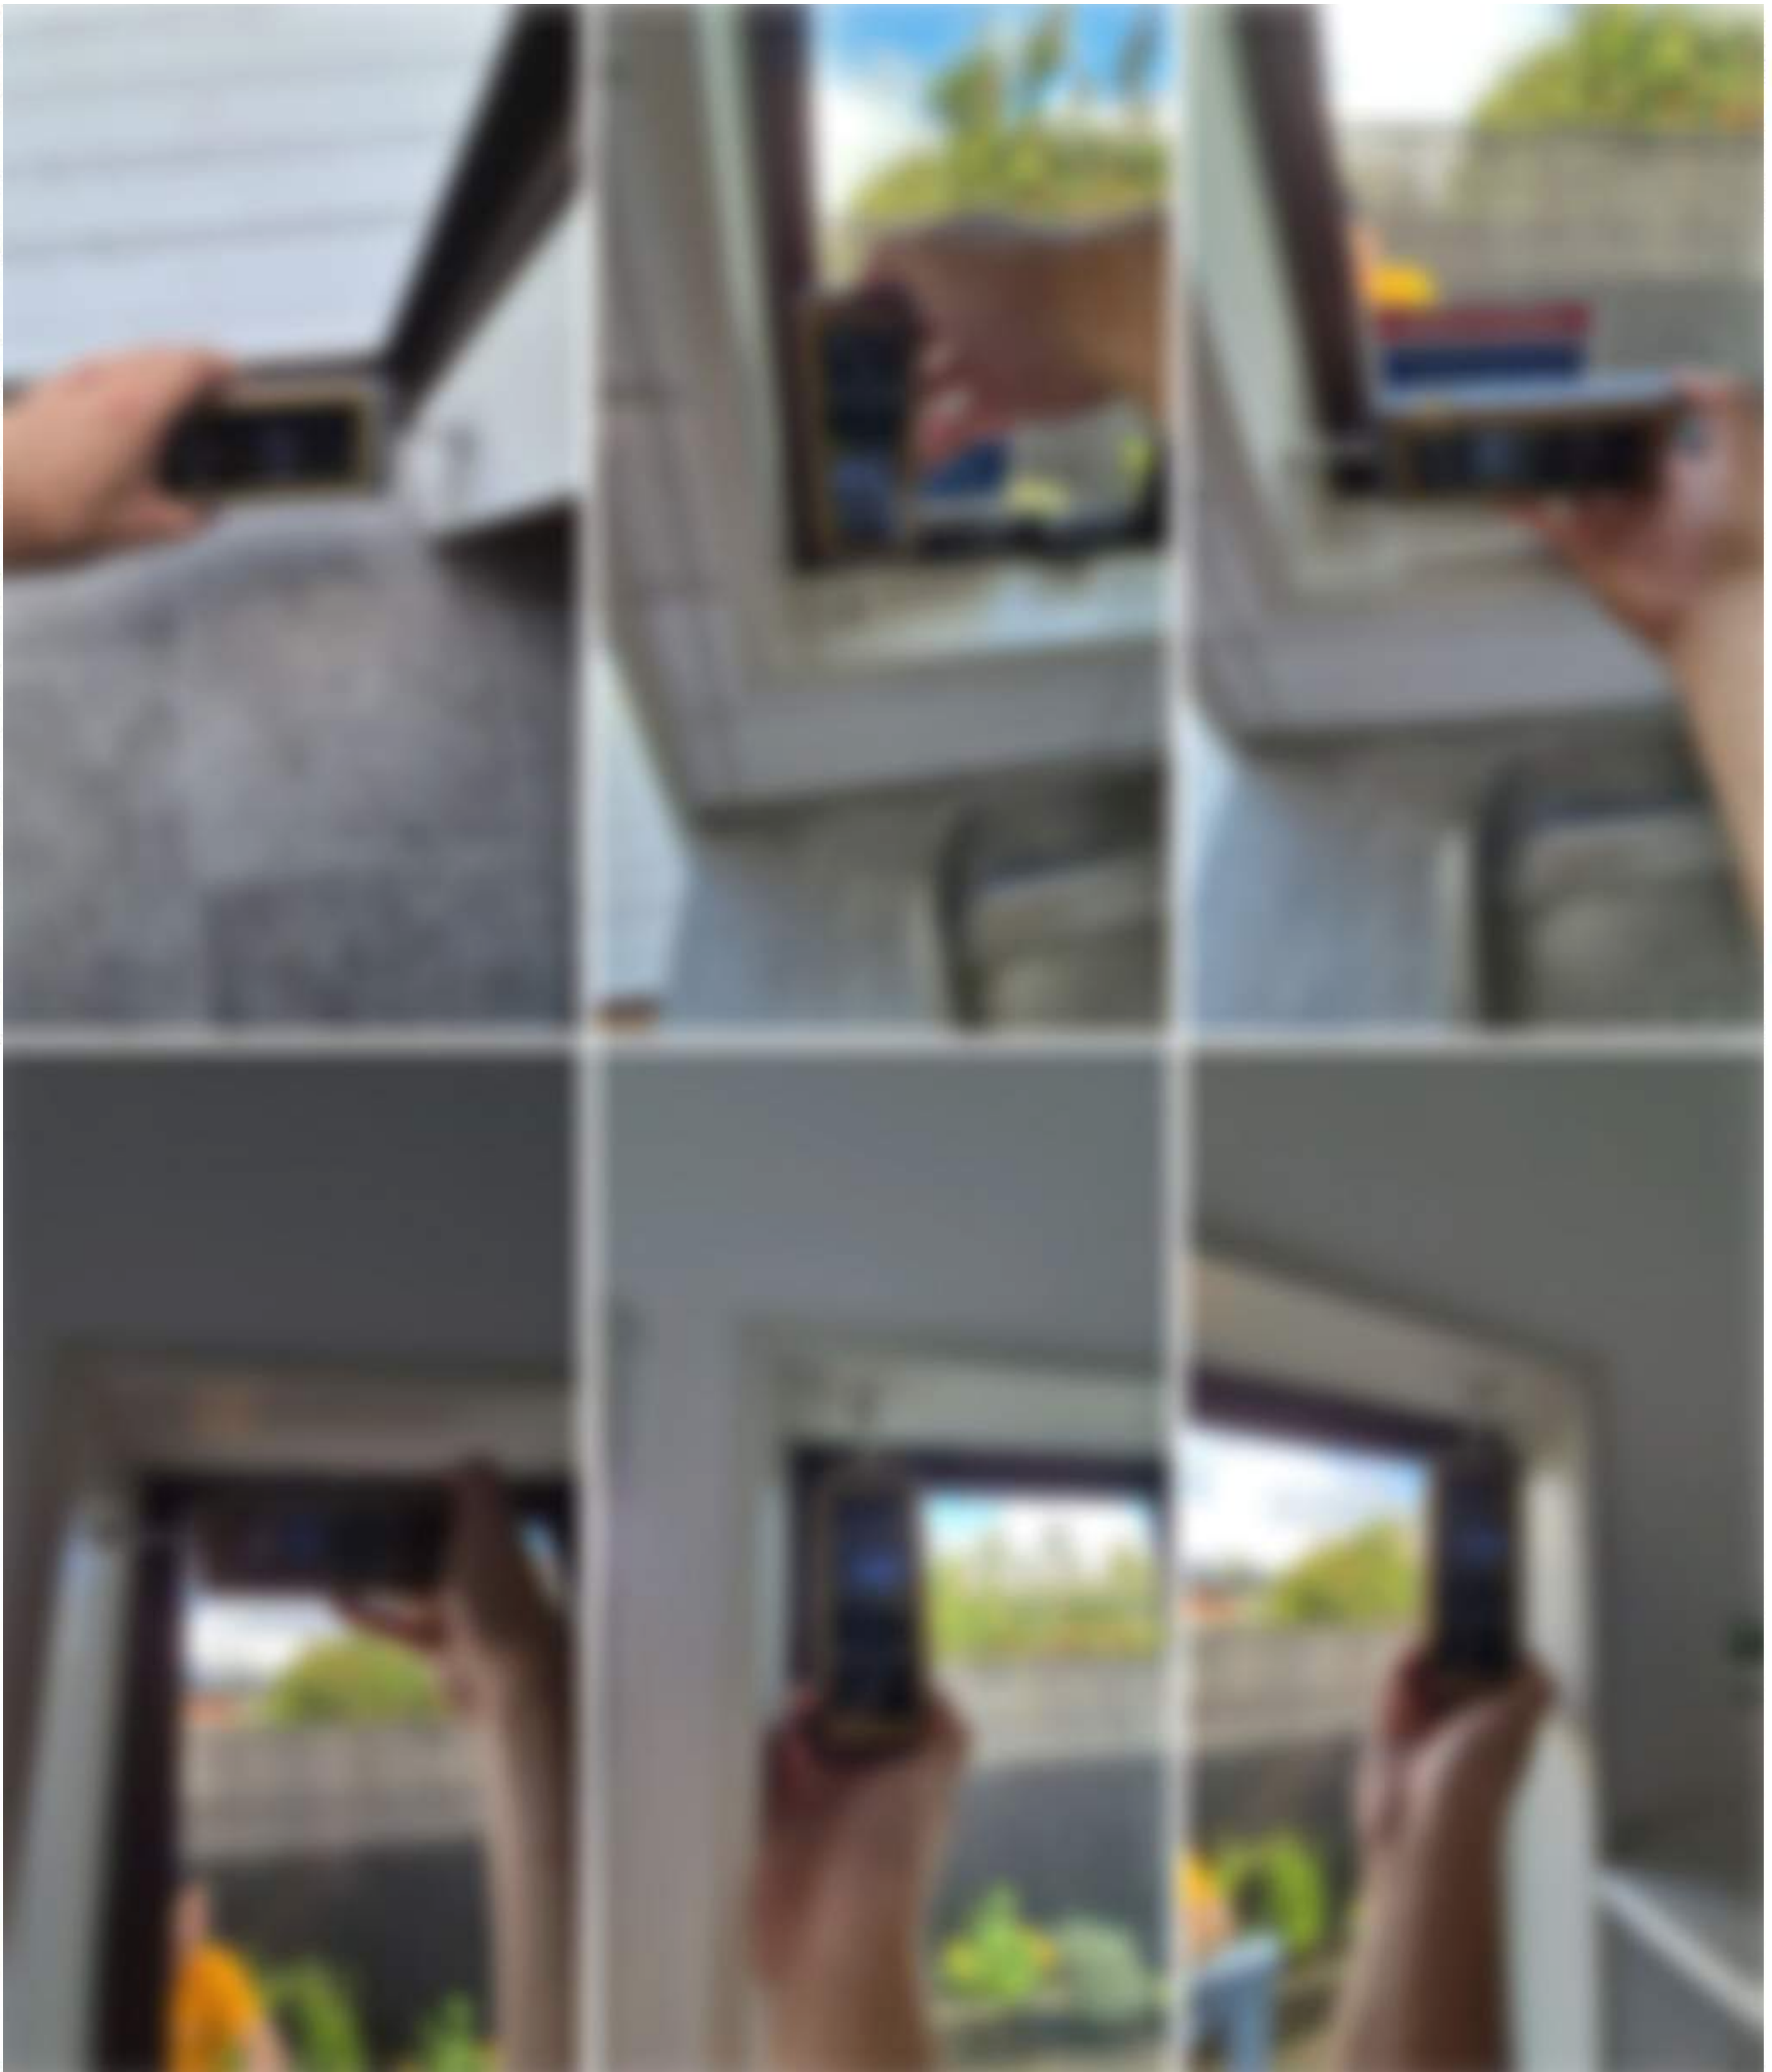
10.10 Laundry

Elevated moisture levels at the joinery or wall, immediate further testing required.

If there is damage present upon invasive testing, the joinery/wall may have to be removed and replaced if it cannot be repaired. Inaction may result in further decay of the structure of the property and financial costs may become significant.

Consult an architect and lbp builder immediately.
