HONEYCOMB

HOUSE INSPECTION REPORT

Inspection Report

INS00012

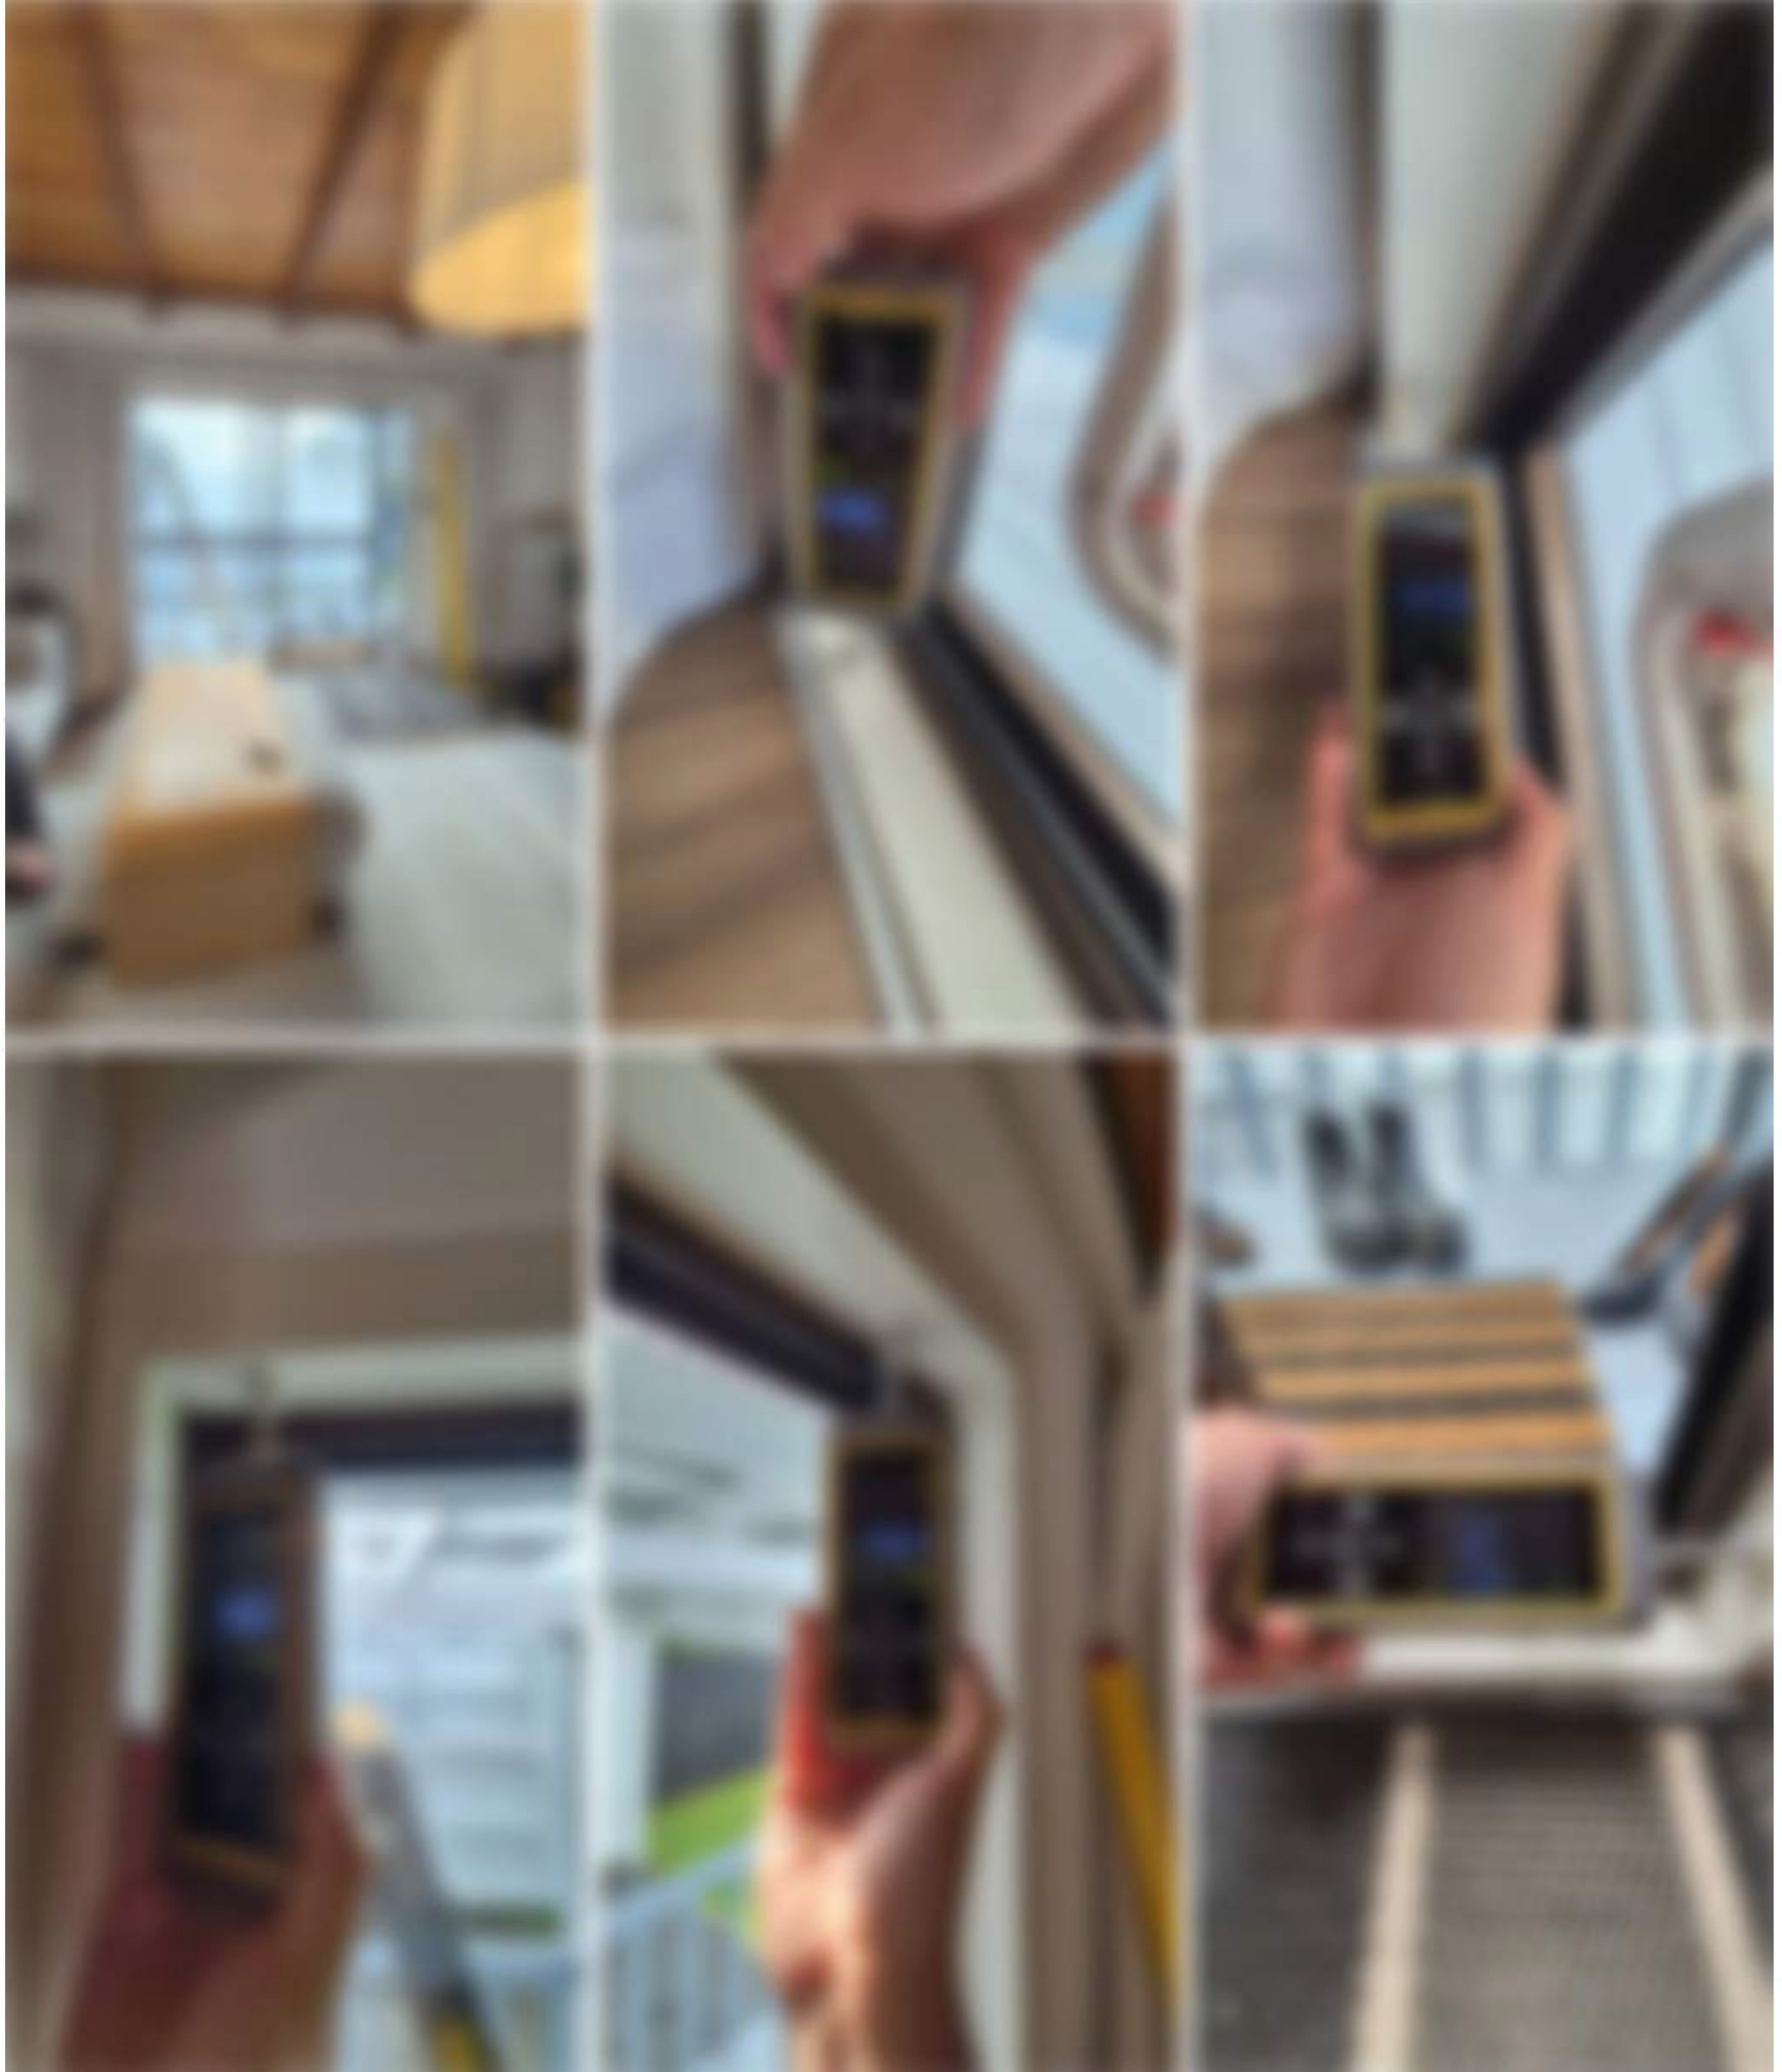
Entrance

Slightly elevated moisture levels. Further investigation required to ascertain if there is any damage that has already occurred.

Additional testing will be necessary at a later time, approximately within half a year, to ascertain whether there is an escalation in moisture levels.

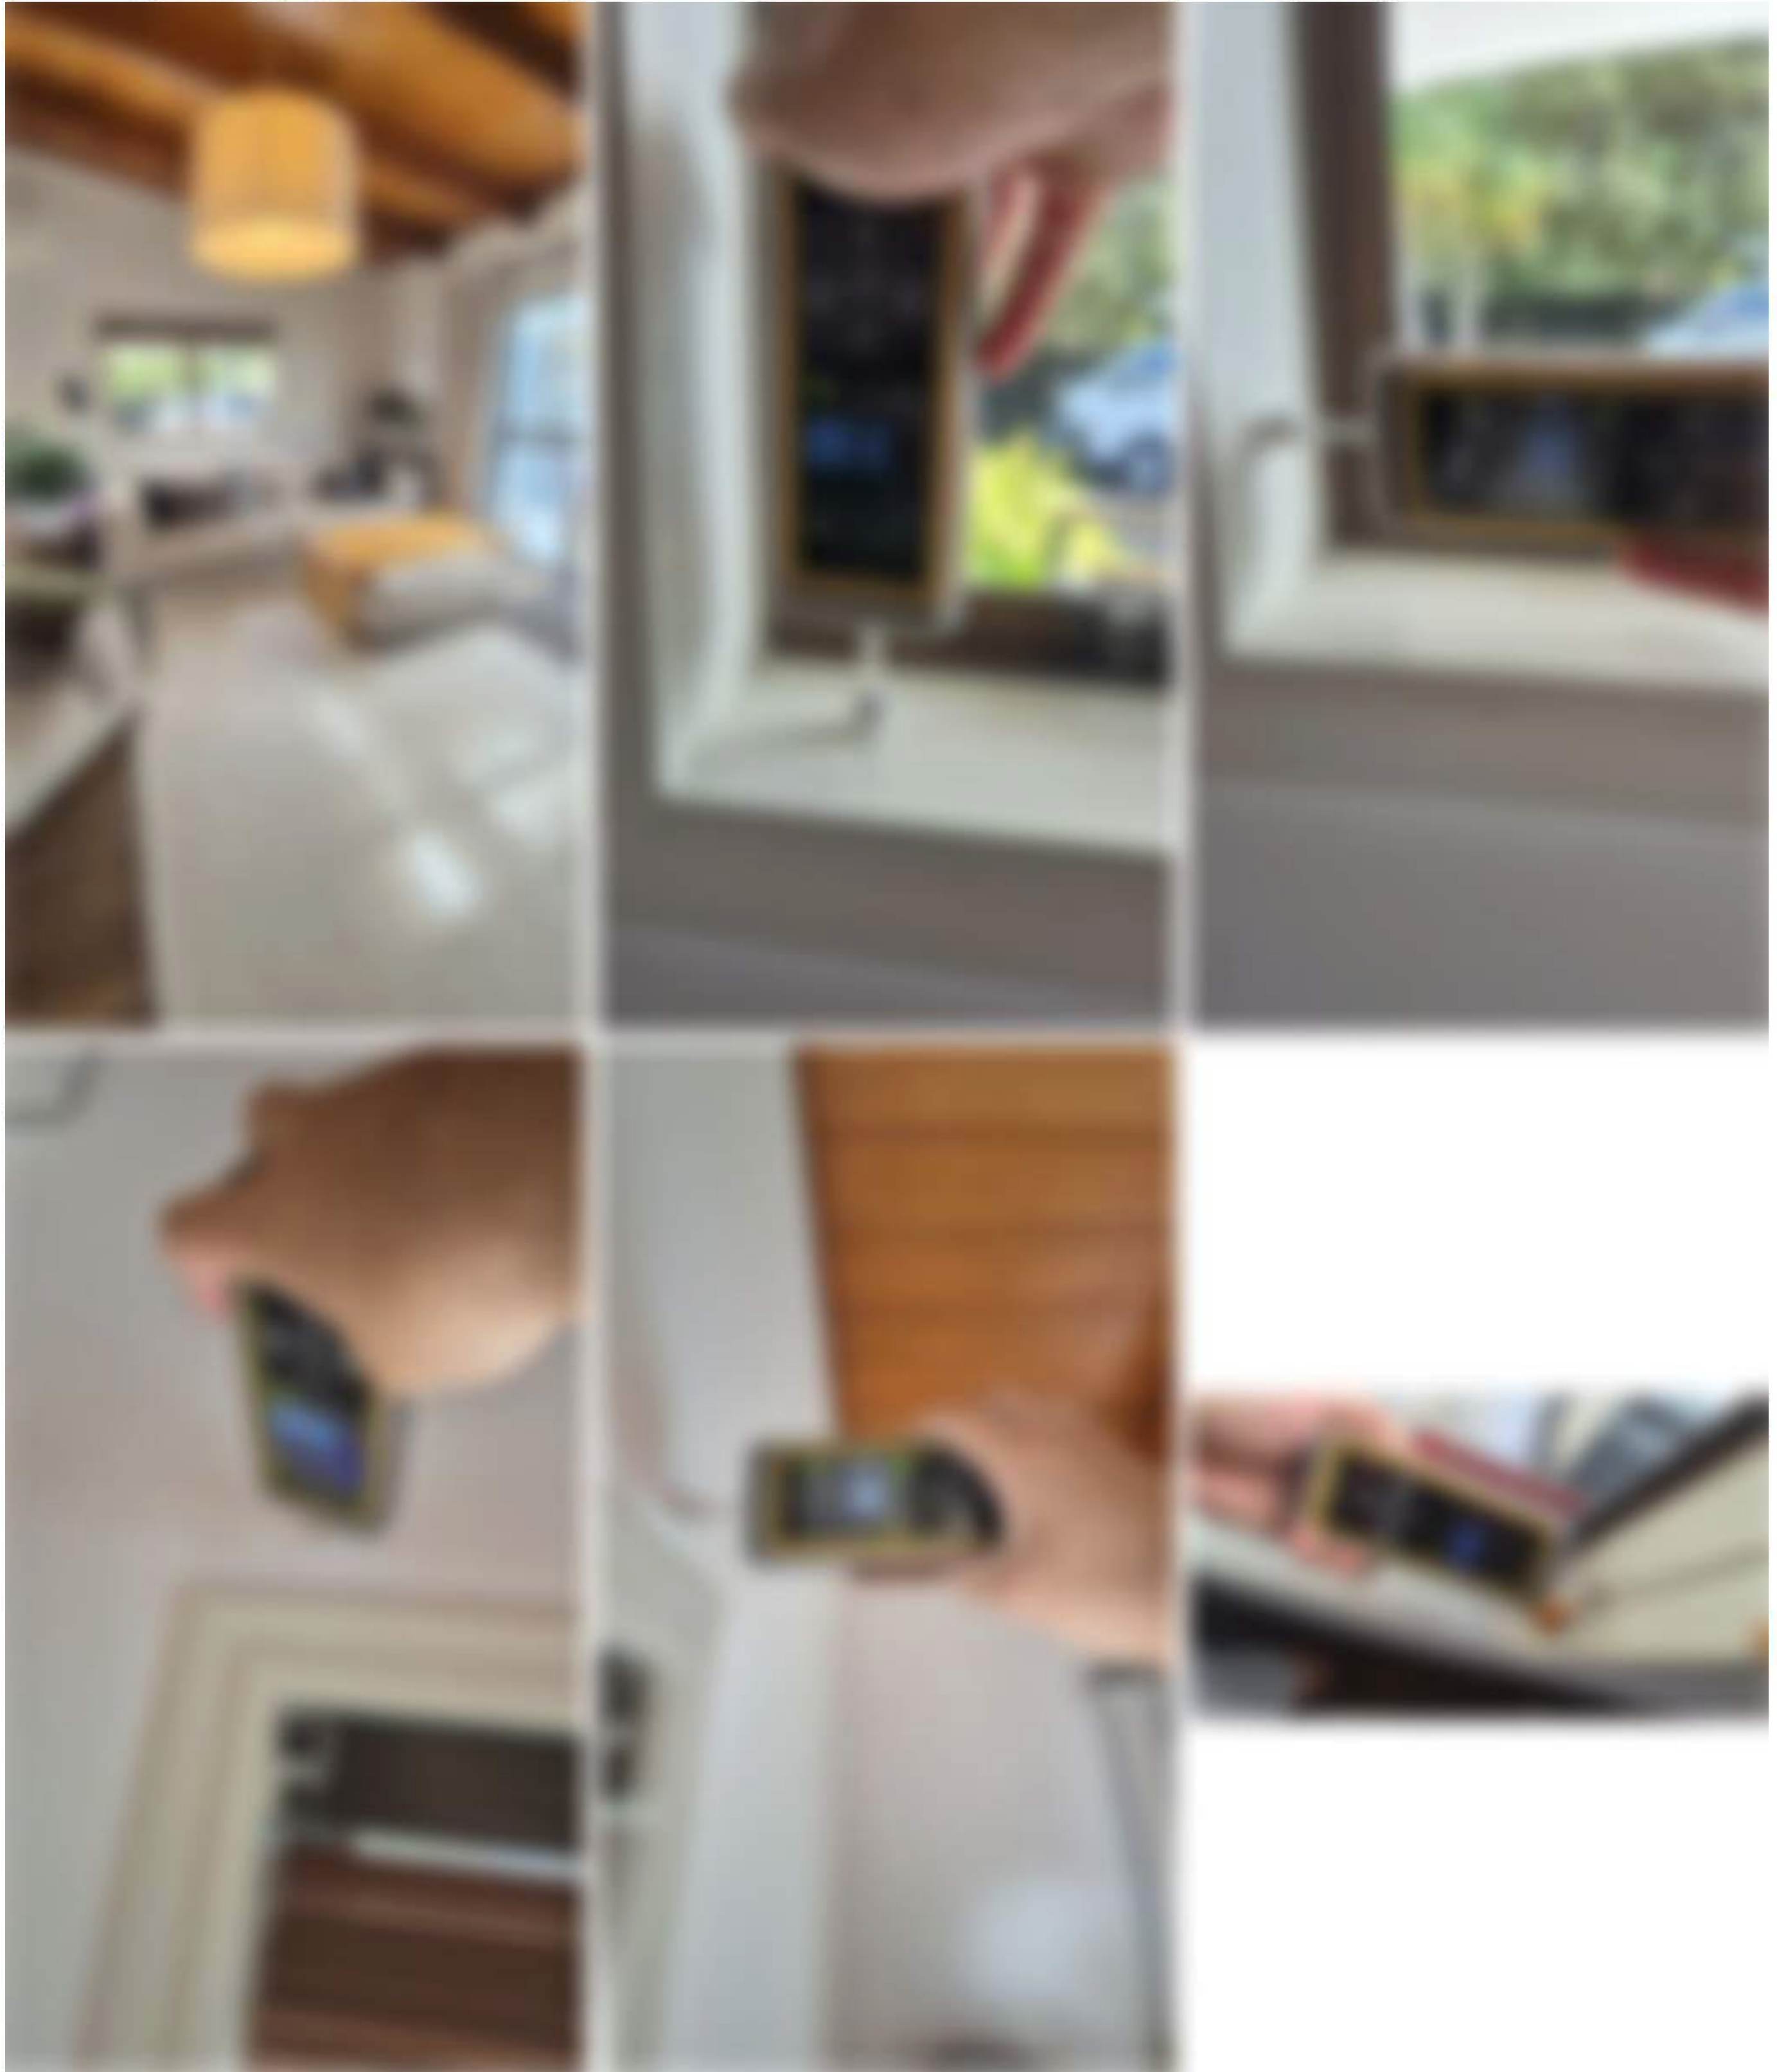
10.2 Dining Room

Moisture appears acceptable at the time of inspection.

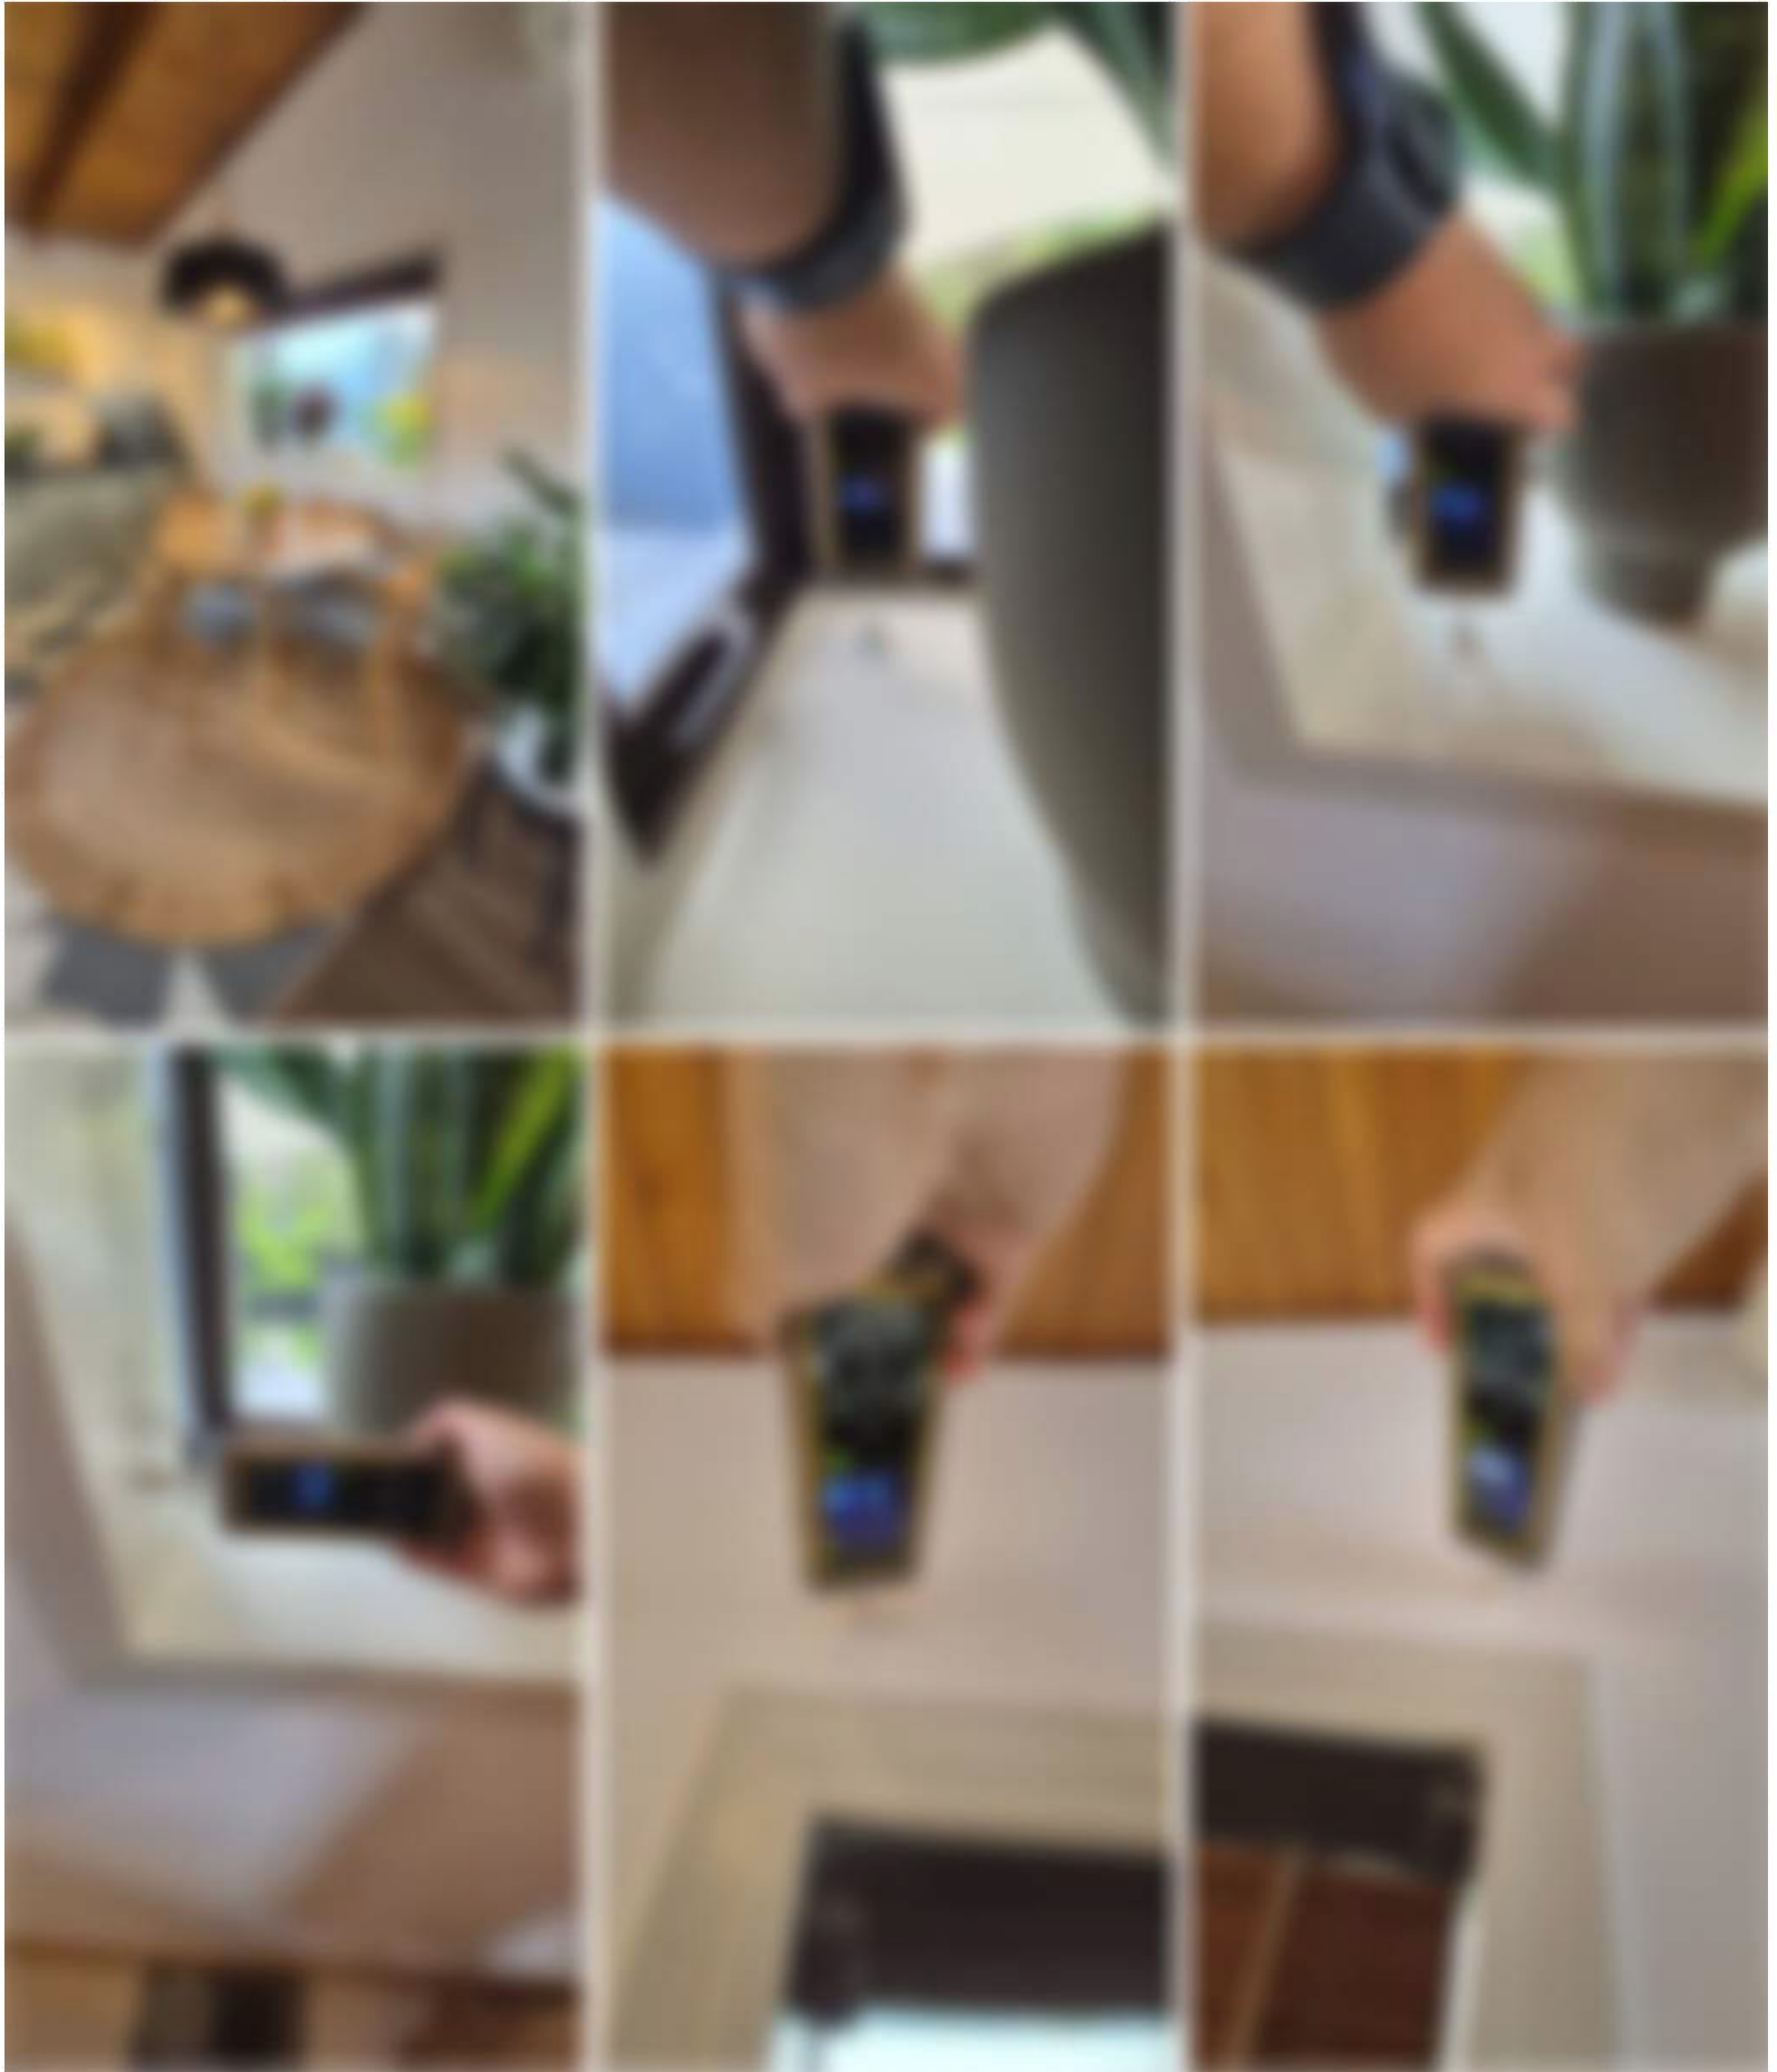
10.3 Kitchen

Moisture appears acceptable at the time of inspection.

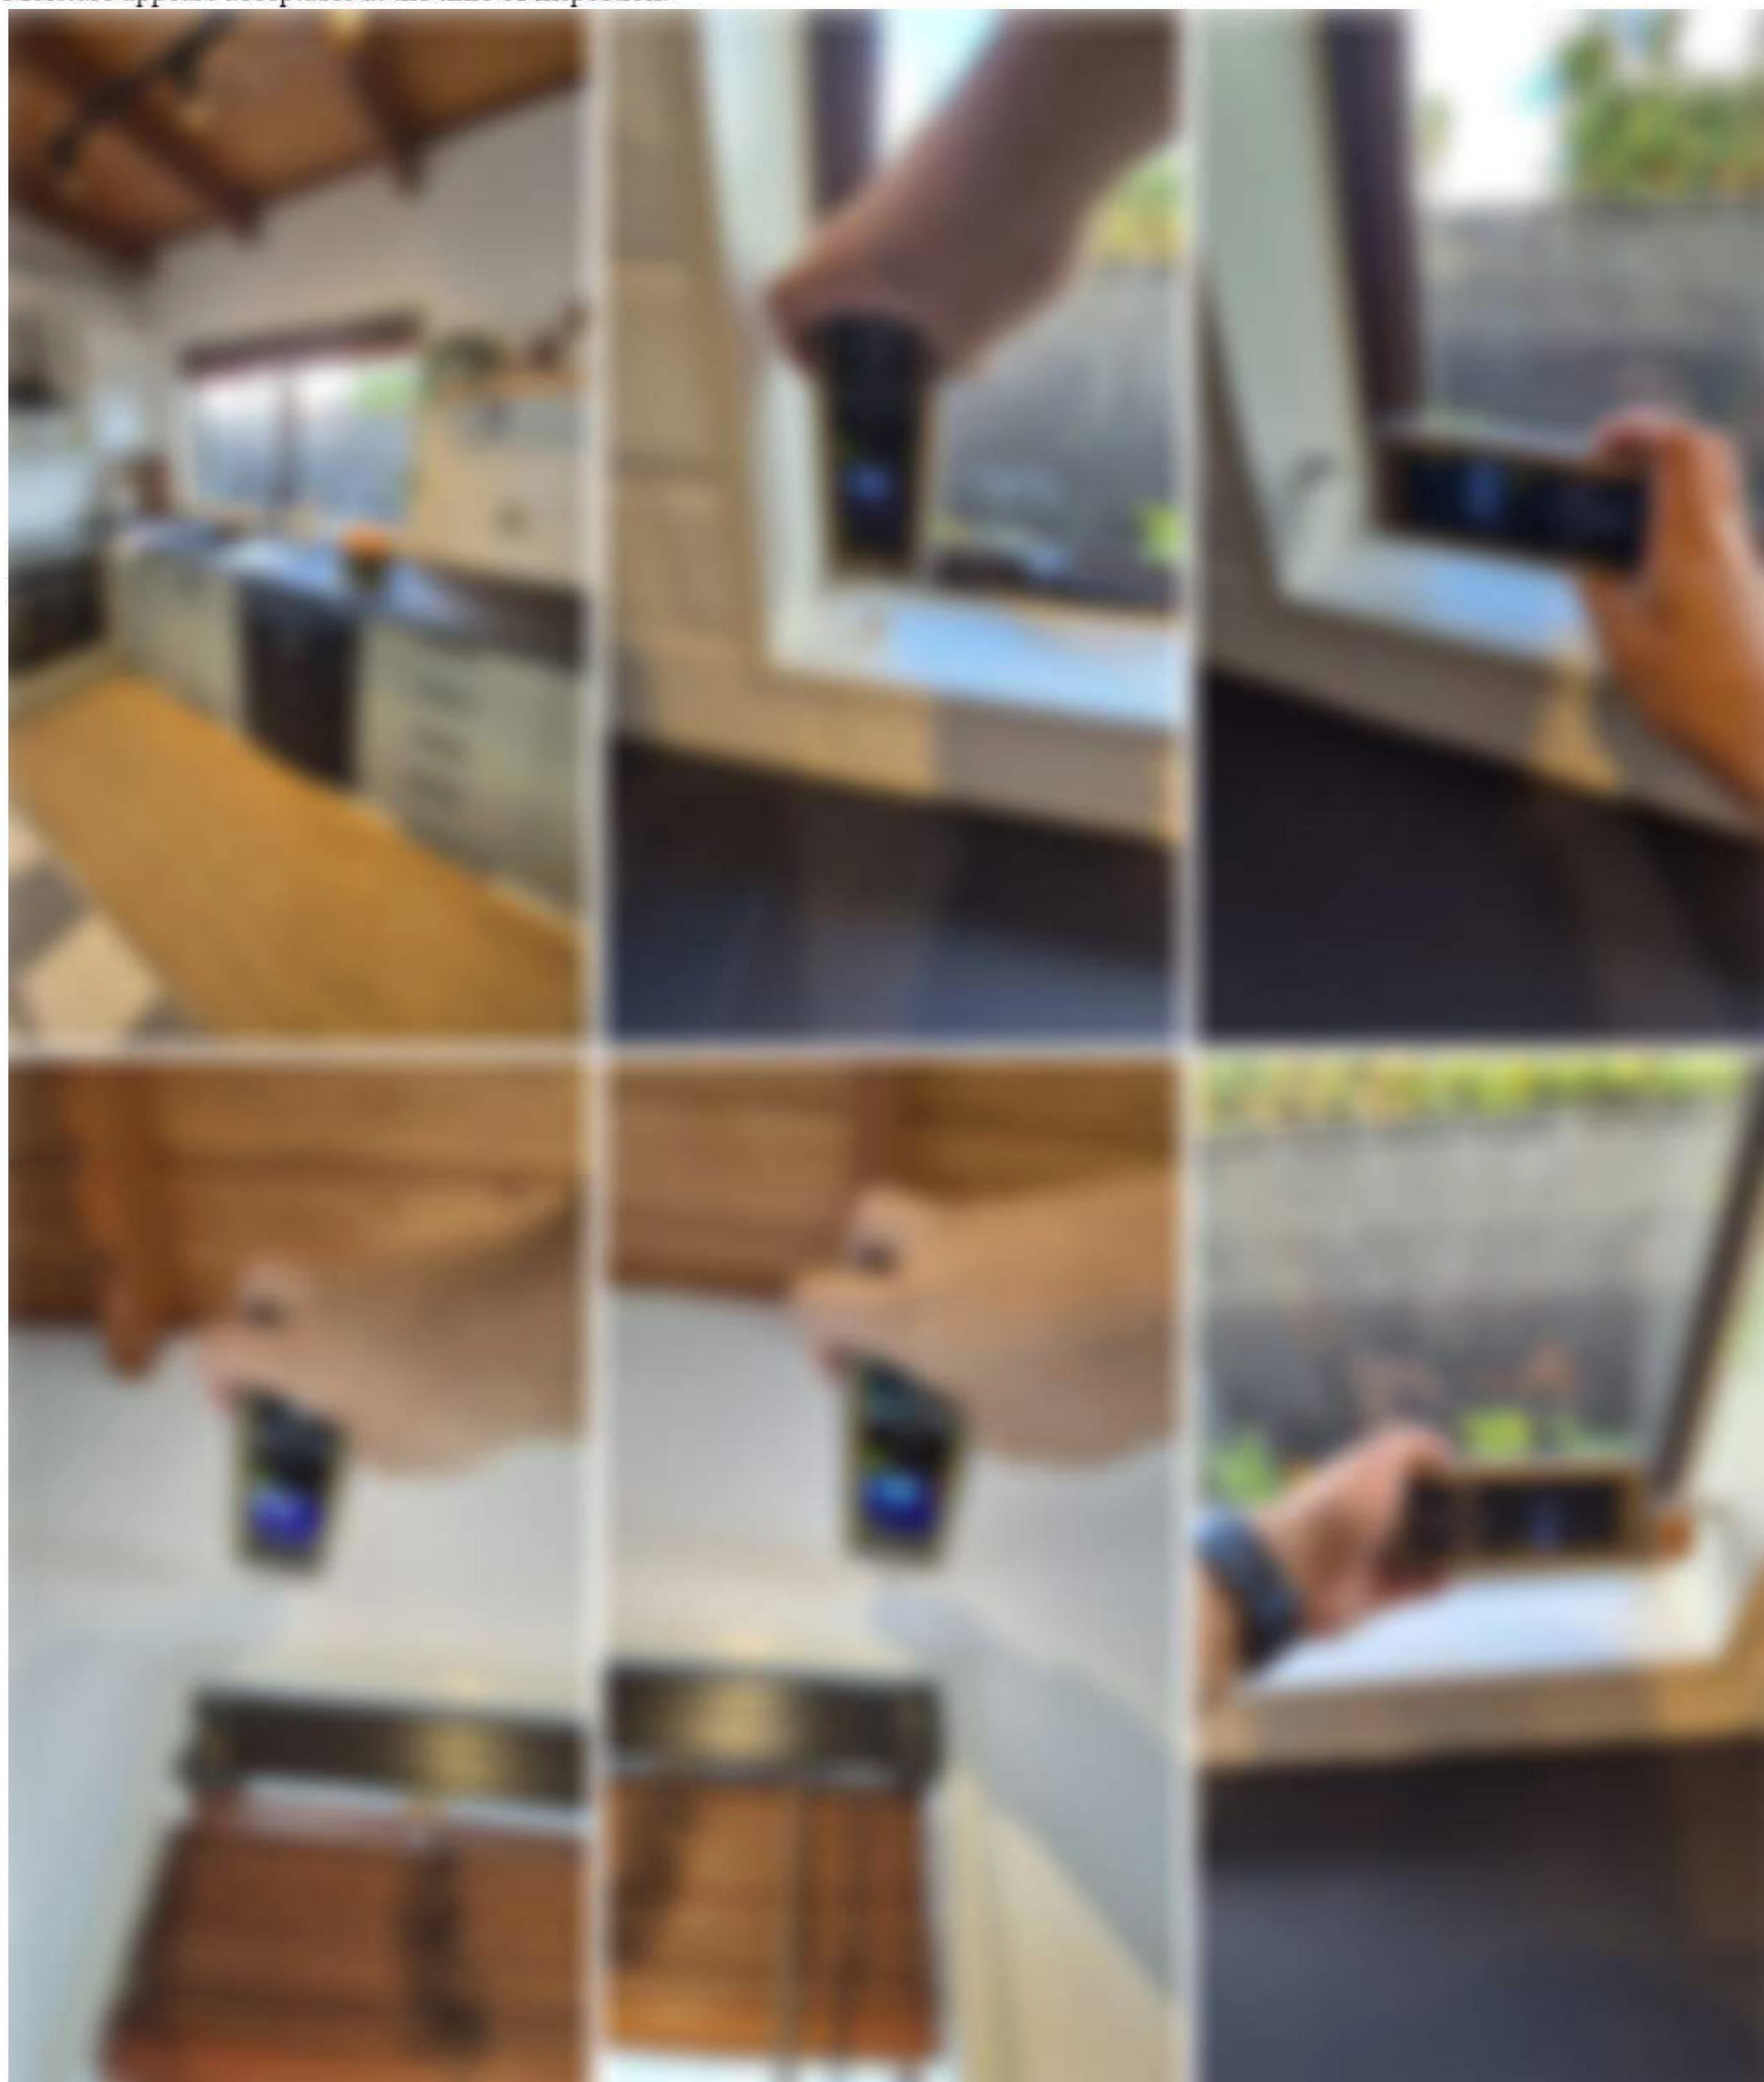
10.4 Bedroom 1

Moisture appears acceptable at the time of inspection.

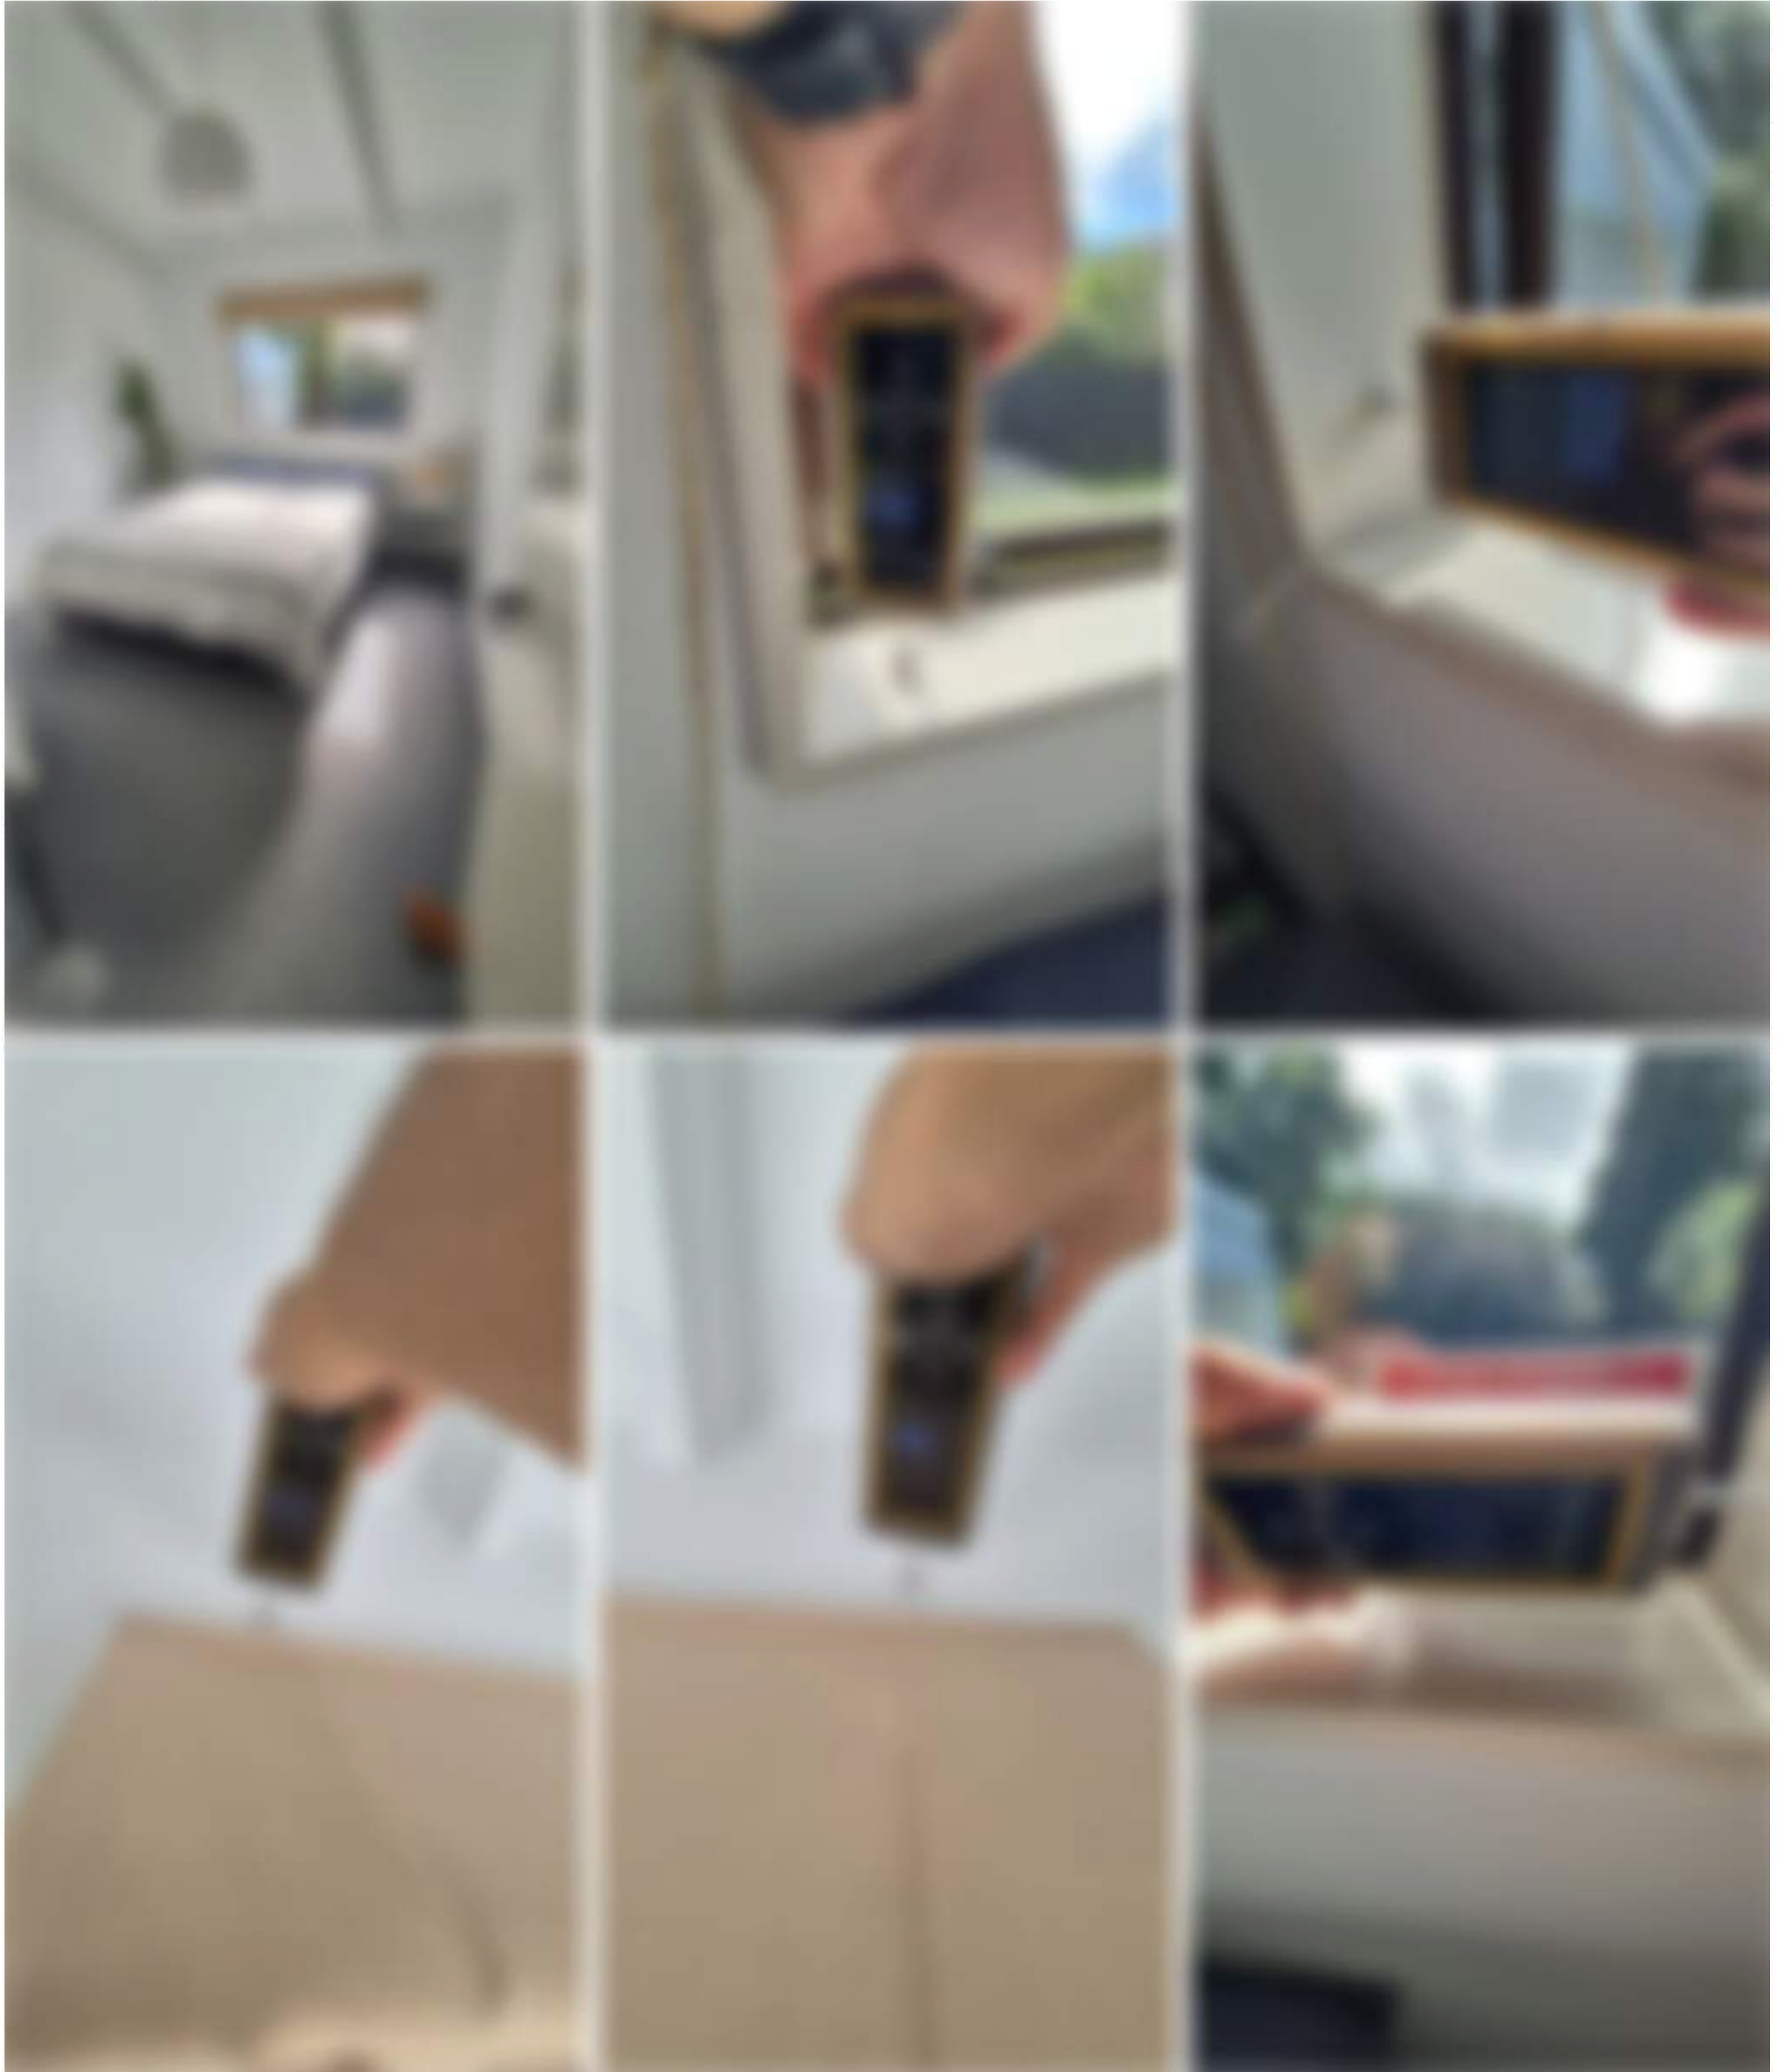
10.5 Bedroom 2

Moisture appears acceptable at the time of inspection.

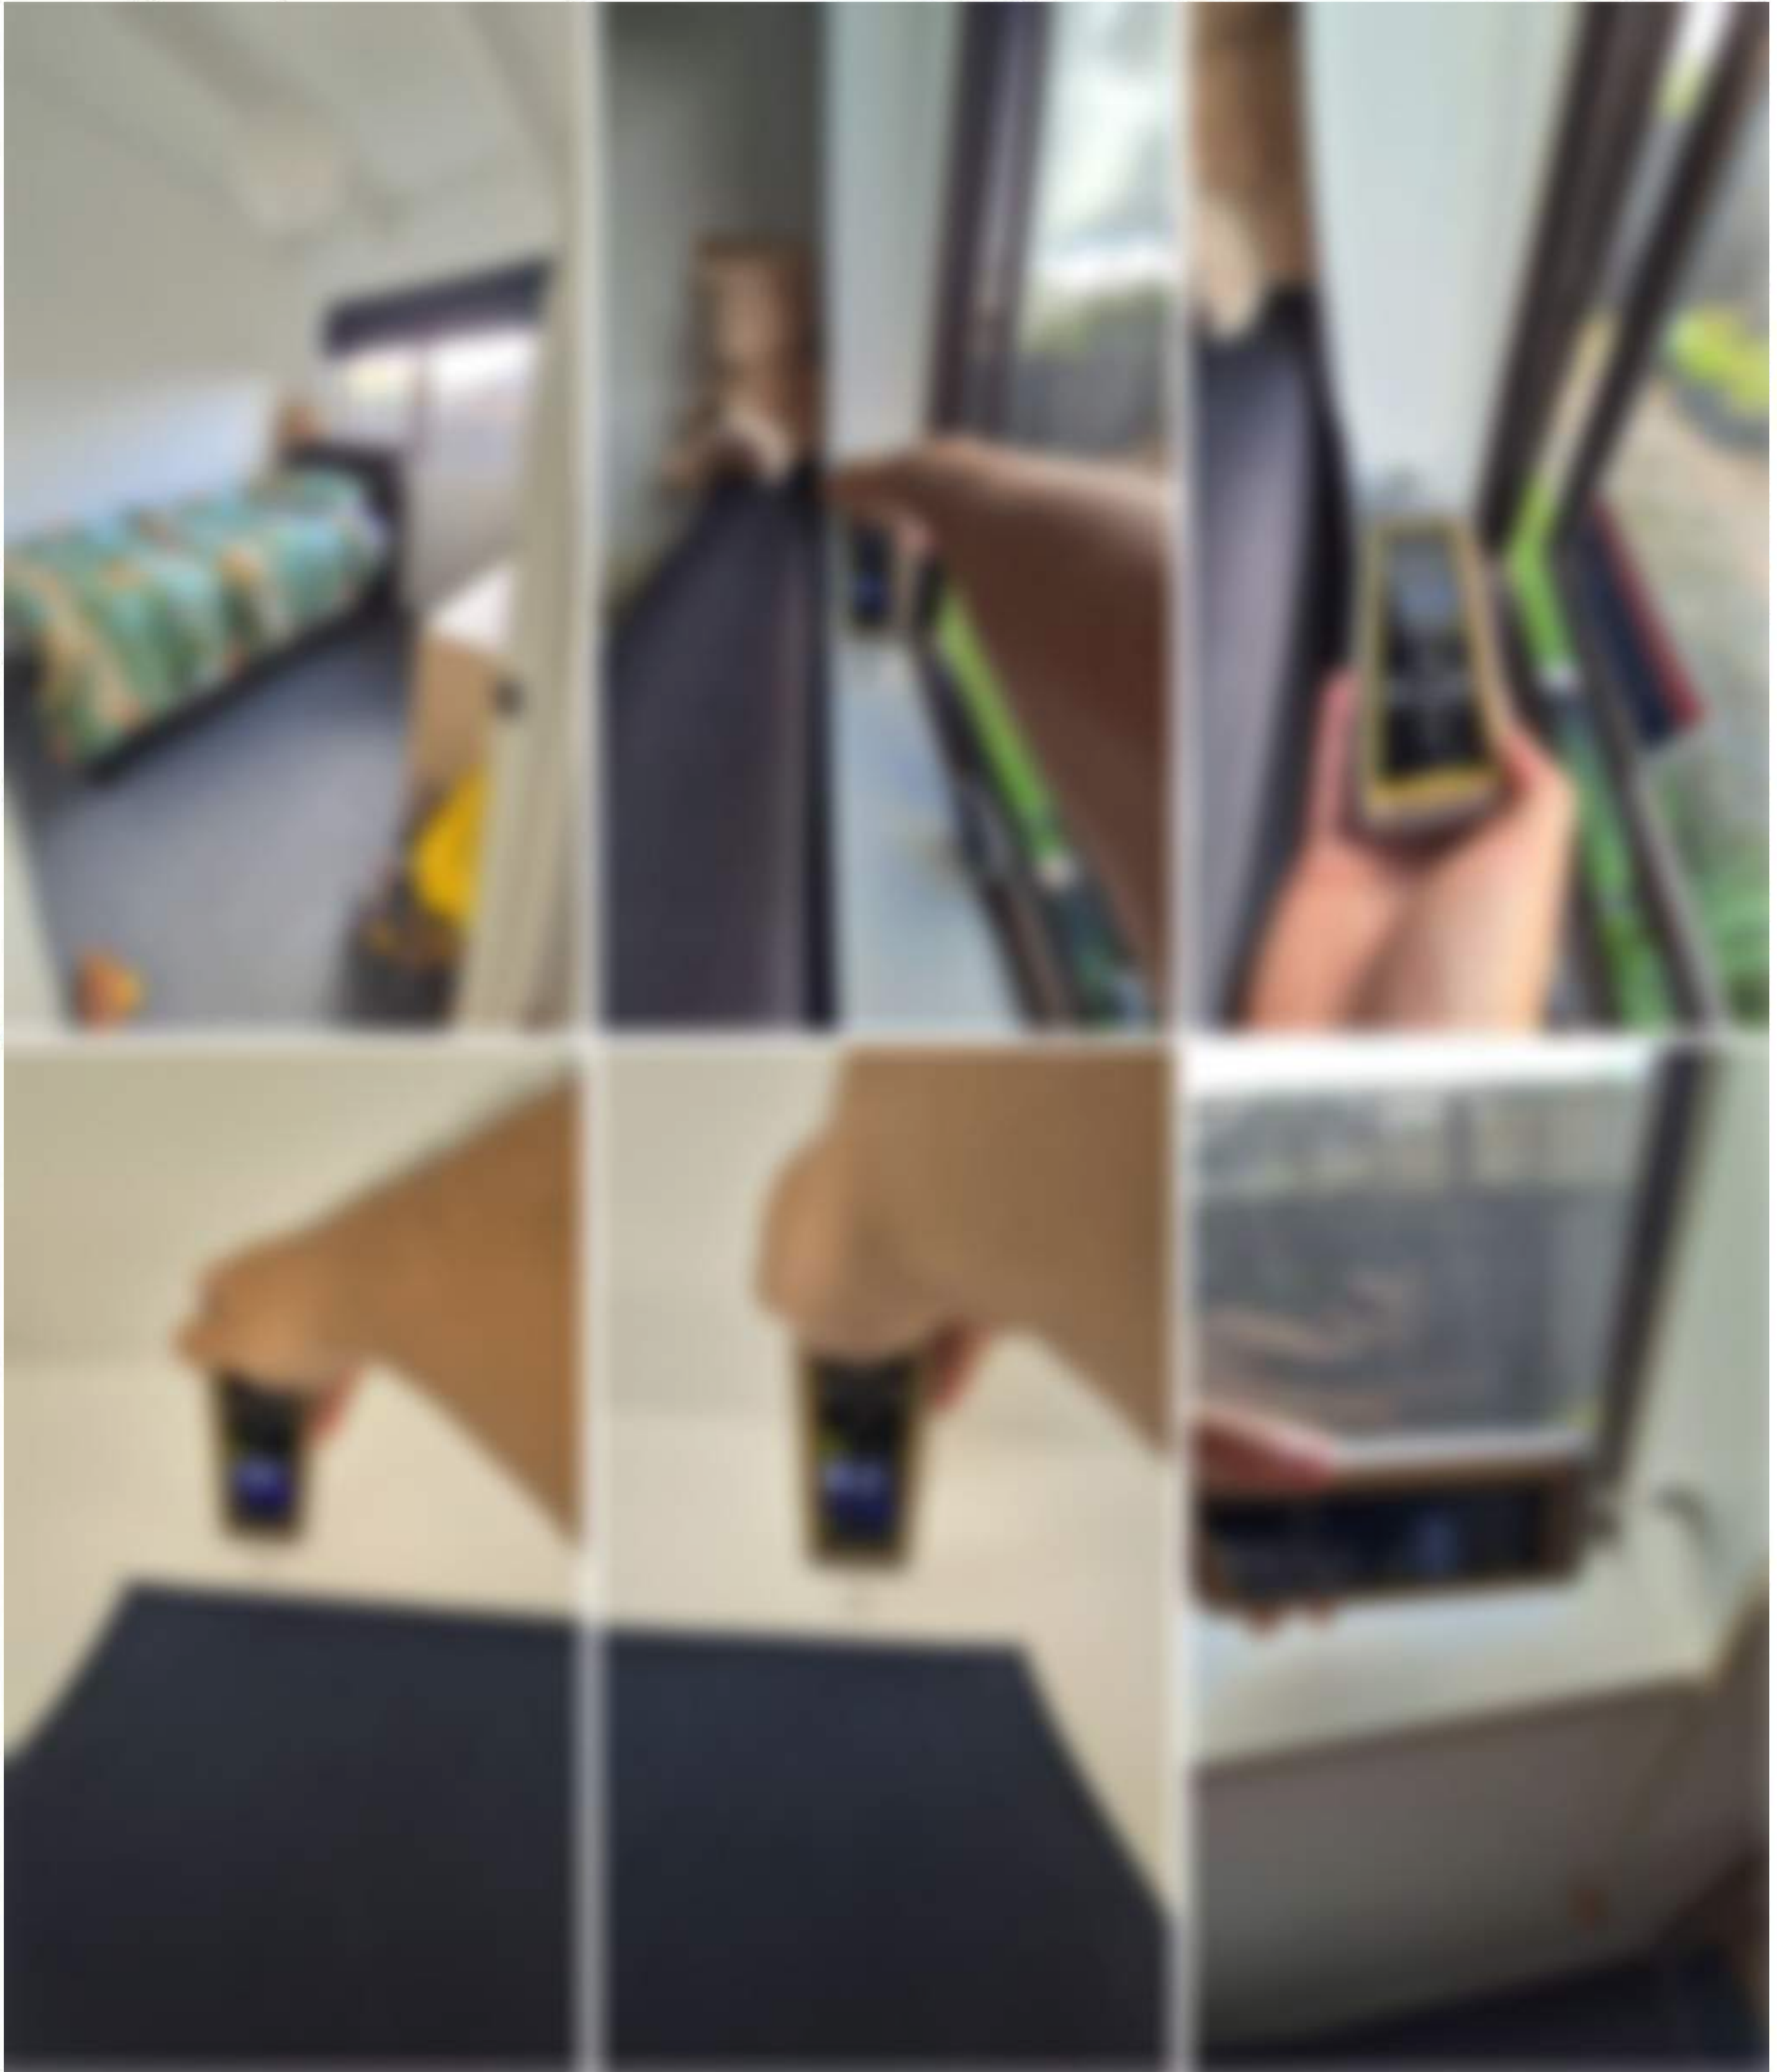
10.7 Office 1

Elevated moisture levels at the joinery or wall, immediate further testing required.

If there is damage present upon invasive testing, the joinery/wall may have to be removed and replaced if it cannot be repaired. Inaction may result in further decay of the structure of the property and financial costs may become significant.
